Ozgu Kasmer
Resat Ulusay
Candan Gokceoglu

Spoil pile instabilities with reference to a strip coal mine in Turkey: mechanisms and assessment of deformations

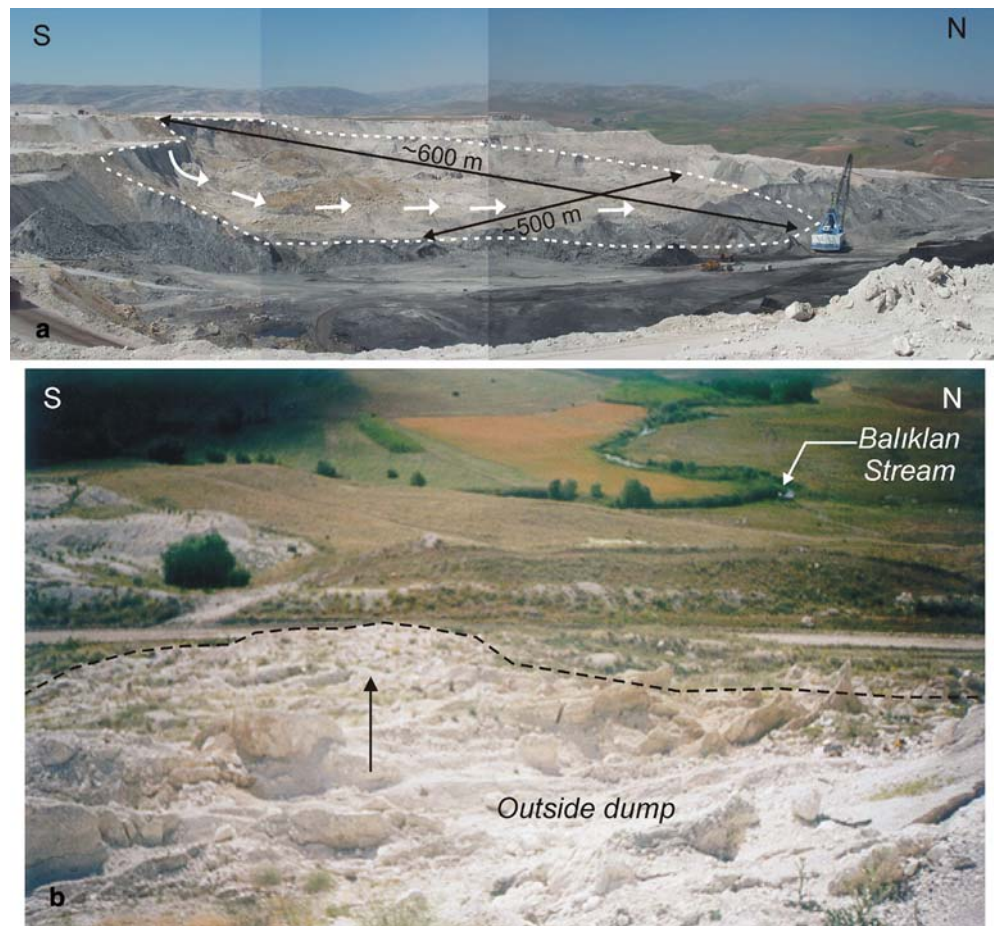
Fig. 1 Panoramas showing the spoil pile instabilities labeled INS1 in the Central Pit (a), and INS2 at the outside dumping area (b)

In the early stages of the investigation, field work in the form of observations and surveying was carried out to deduce the basic characteristics of the large spoil pile failure (INS1) in the Central Pit (see Fig. 1a) and the small-scale failure (INS2) in the old outside dumping area (see Fig. 1b).

A small and local instability (INS2) also occurred in 2002, during the site investigation stage of this study, at the old outside dumping area, which is located on natural slopes dipping to the Balıklıan stream (see Fig. 1b). Some tension cracks 5–10 cm wide and settlements of

about 40 to 50 cm on the road connecting the Central Pit to the recreation area were observed. In addition, heave and seepage at the toe of the spoil pile were evident. However, the movement did not extend to the haul road and did not affect mining operations. Observations and the natural topography, underlying the dump, indicated that the failure occurred along a spiral surface passing through the spoil material in the upper benches and following the topographical surface at the base of the spoil pile.

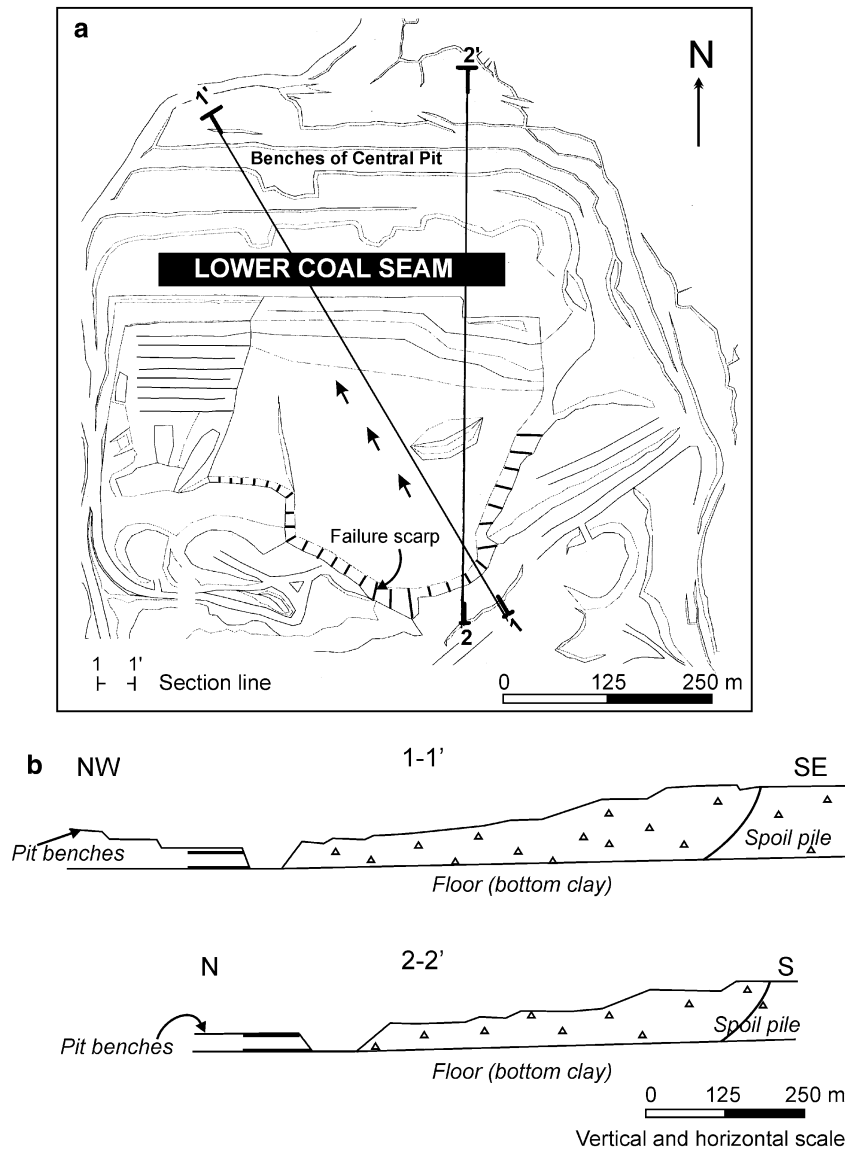
INS1 occurred on the evening of the 10 June 2001 in the central part of the inside dumping area of the Central Pit. Due to lack of monitoring studies before the failure, no information about the rate of the movement is available. Based on information from mine personnel, only few tension cracks behind the crest of the dump were noticed for the first time some weeks before the failure occurred. Prior to the failure, the dump height was 40 m at the pit edge and 115 m at the crest (Fig. 6). The overall slope of the dump was 12° and there was a 65 m wide berm at 1,584 m elevation, 15 m below the dump crest. The distance between the highwall and the back slope of the failure face was about 600 m. The failure involved 20,000,000 m³ spoil material and covered an area of approximately 0.3 km².

Fig. 6 **a** Simplified plan of instability INS1 and **b** typical cross-sections of spoil pile geometry deduced from surveying before and after the instability

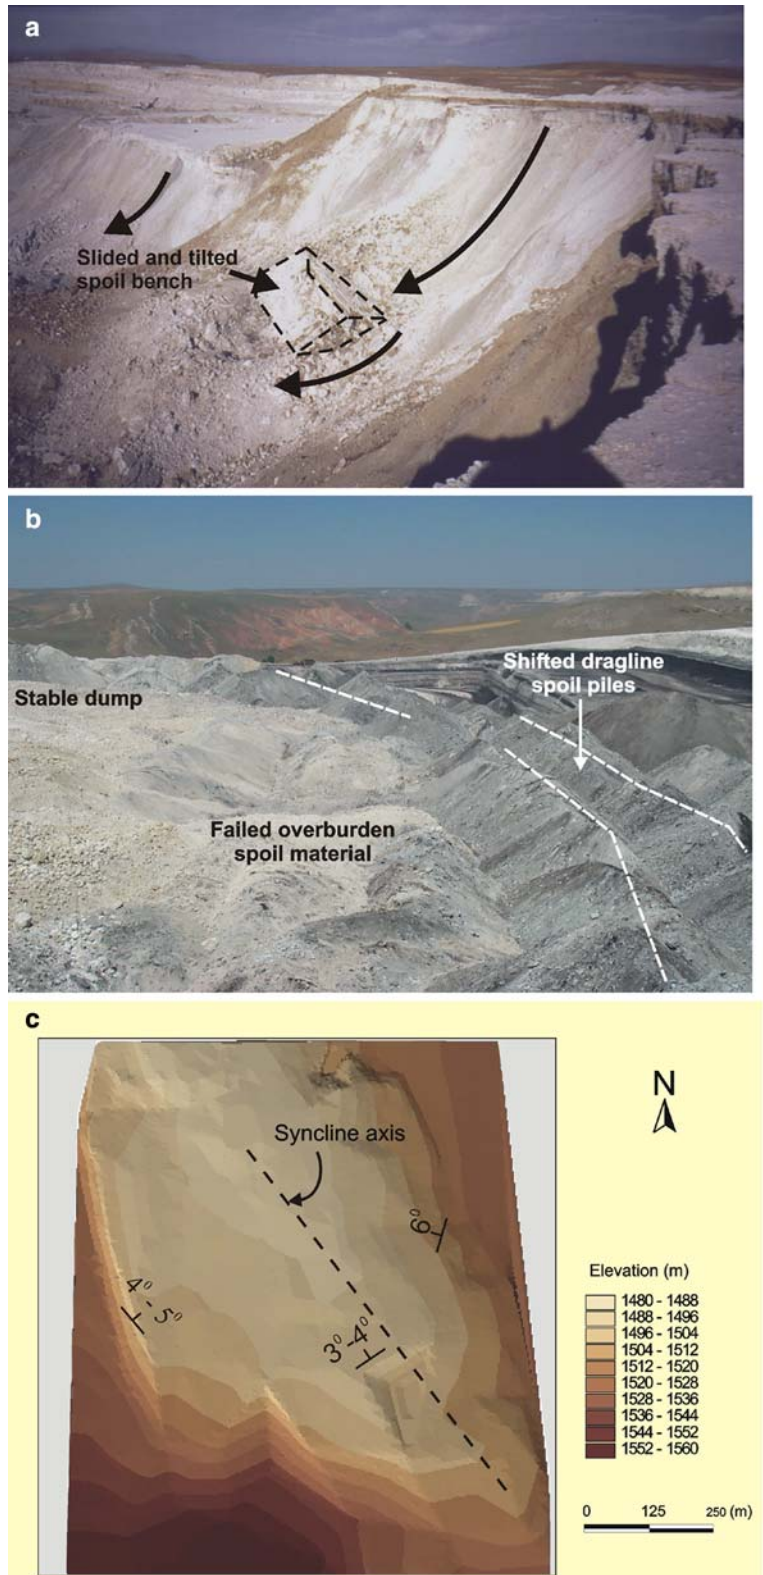
Observations and the inclination of the floor showed clear evidence of the mode of failure. At the back of the failure, there was a well defined scarp where failed

material at the base of the failure has dropped lower in elevation than material at the front (Fig. 7a). Some backward-tilted sections of the uppermost spoil benches moved down along this surface as seen in Fig. 7a. This would suggest that circular failure (rotational movement) initiated the failure from the back of the dump where the dump height was at a maximum. The dragline spoil piles moved roughly horizontally, with no discernible change to their conical shape (Fig. 7b). This suggests that the toe of the dump underwent a translational movement parallel to the base of the pit floor. A discrete interface between the failed dump and the area to the west, which did not fail, was evident. The contour plan of the pit floor indicates that the failed dump lies above a syncline-shaped structure with limbs dipping at 4° and 6° to the east and west, respectively, and with a plunge of 3° – 4° towards the highwall (Fig. 7c). These observations suggest a combined failure consisting of a circular sliding surface passing through the spoil material at the upper part of the dump and a planar surface along the interface between the bottom clay (floor) and the interburden dragline spoil piles (Fig. 8). The floor geometry facilitated movement of the spoil material towards the mining face and is possibly one of the most important contributors to the instability.

Fig. 7 **a** Scarp (circular failure) of instability INS1, **b** horizontal dislocation of dragline spoil piles, and **c** contour map of the floor in the Central Pit

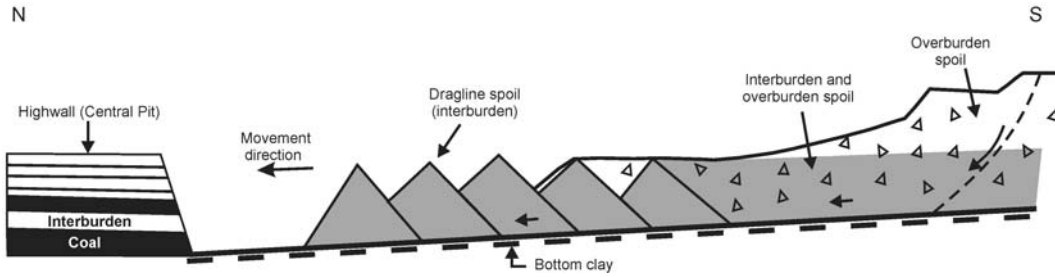
Fig. 8 Section through the spoil dump illustrating failure mechanism for instability INS1 (not-to-scale)

In the back-analysis of INS1 instability, the failure mechanism depicted in Fig. 8 was considered. In addition, based on the sharp decreases in shear strength post-peak for the materials investigated, it was considered to be realistic to assume that the spoil pile materials and weak interface between the floor and the dumps exhibited shear strengths at or approaching the residual values at the time of failure. Therefore, the minimum values of residual shear strength parameters of the overburden spoil material and bottom clay given in Table 2 were utilized in the analyses. Considering that the beige colored silty material is the dominant overburden material in the spoils dumped by trucks, its residual shear strength parameters were used to represent the shear strength of the circular part of the failure surface.

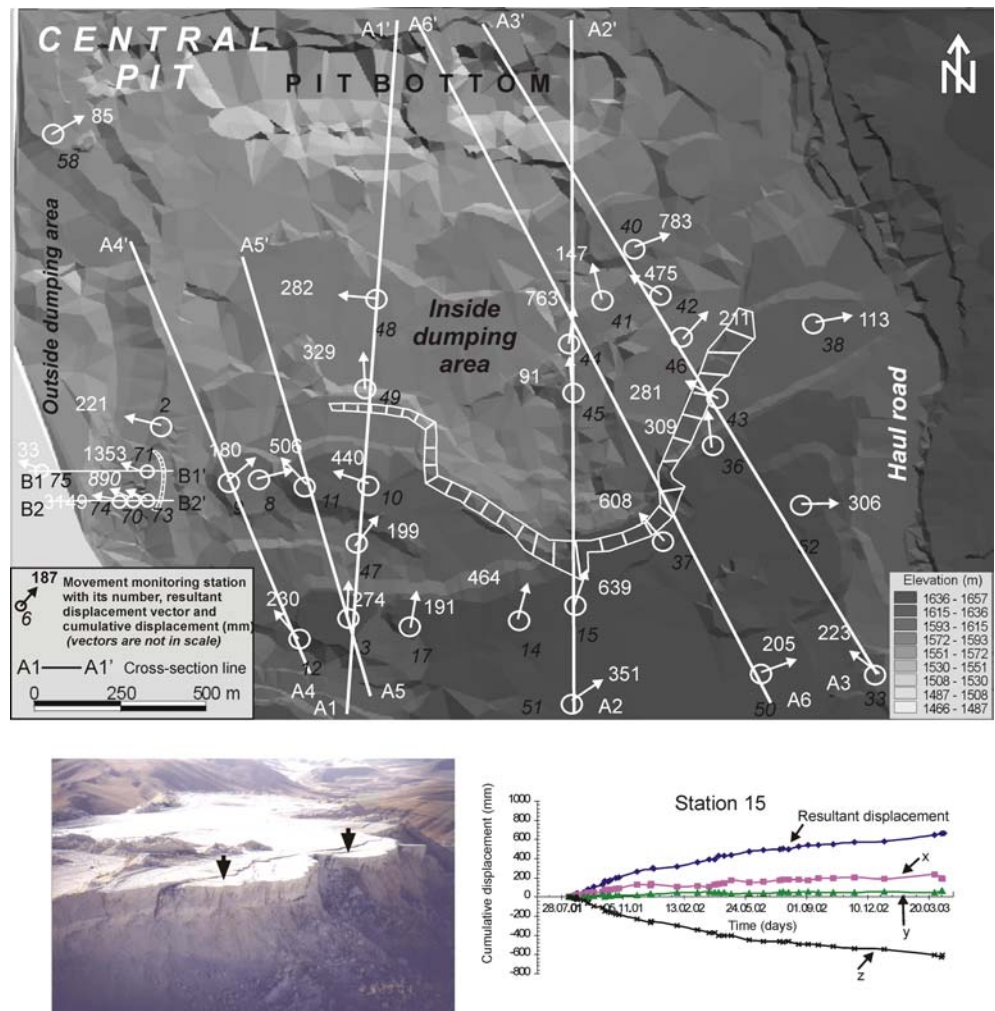
The cumulative displacements of stations 13, 14, 15, 17, 36, 37, 43 and 47, which are situated at the back of the instability INS1, ranged between 191 and 639 mm (see Fig. 10a). These stations were moving downwards

at plunges (deviation from horizontal plane) of 60° – 75° . Magnitudes of movements at stations 15 and 37 were greater than those at other stations mentioned due to the movement of the suspended spoil blocks located at the crest of the failure and bounded by tension cracks and the failure scarp (Fig. 10b). Greater cumulative displacements at stations 40, 42 and 44, which are located at the lower part of the instability, resulted from the compaction of spoil material dumped to provide a buttress to contain the failed material. A typical example of time versus cumulative displacement from one of the stations established in the area of INS1 is depicted in Fig. 10c. It is clear from the graph that displacements in the vertical direction generally control the movement after the failure throughout the monitoring period. All time versus cumulative displacement plots from the

target stations indicate that displacements clearly tend to decrease after February 2002.

Fig. 10 a Locations of movement monitoring stations and resultant displacement vectors, **b** a suspended spoil block on the backscarp of INS1, and **c** a typical cumulative displacement versus time plot.

monitoring studies should be continued both in the Central and South Pits.

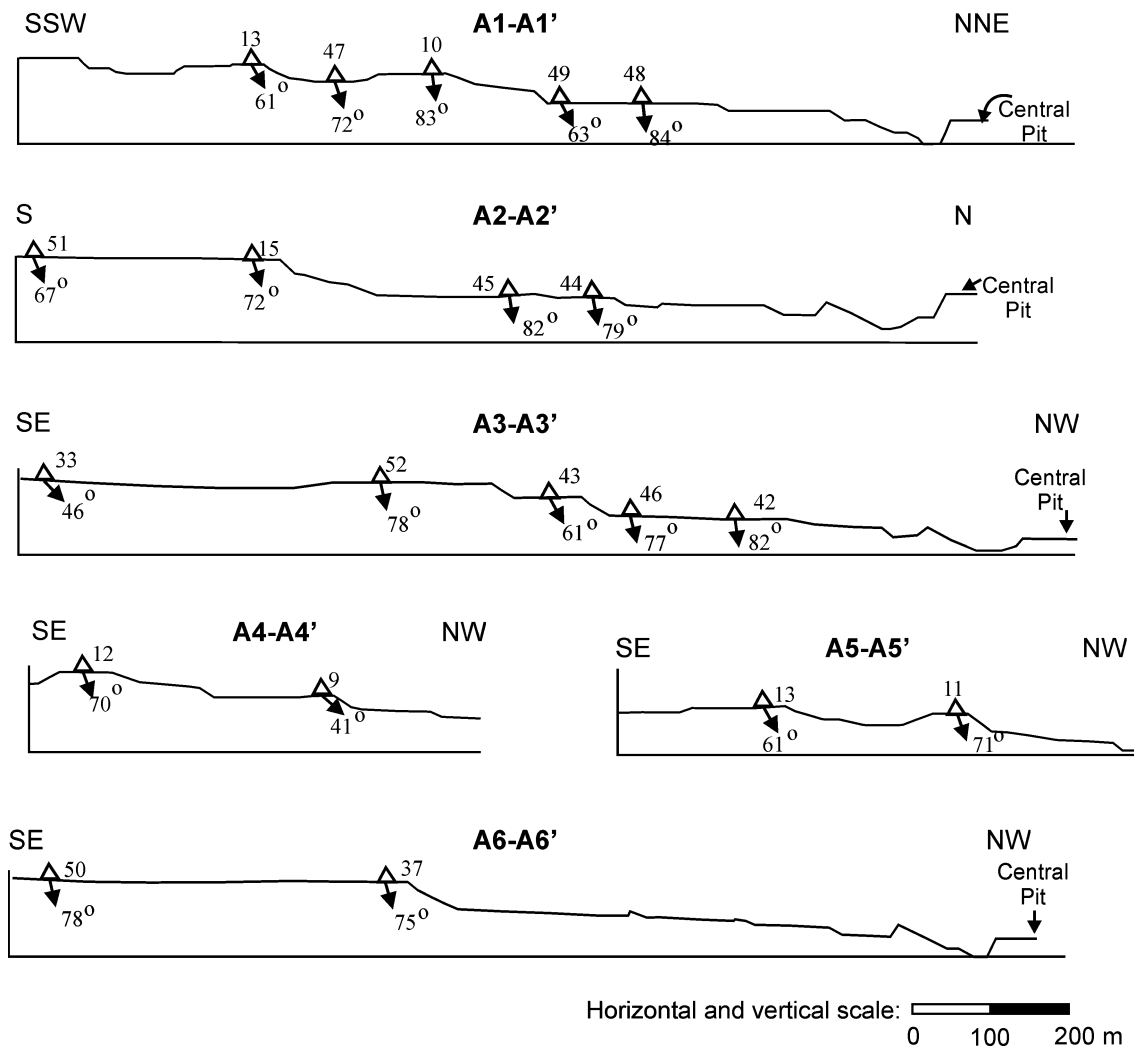
Six cross sections from different parts of the failed spoil pile were prepared and the resultant movement vectors are shown on these cross sections (Fig. 11). The directions of the movement vectors shown in Fig. 11 confirm the above assessments. Therefore, it can be concluded that the large-scale spoil failure (INS1) is not still active, and the ongoing deformations are mainly due to the compaction of the spoil material. In addition, movement of the individual spoil blocks, which rest on the back scarp of the failure surface, also contributes to the deformations measured at the stations close to the crest.

Fig. 11 Cross-sections from instability INS1 showing resultant movement vectors with their plunges.

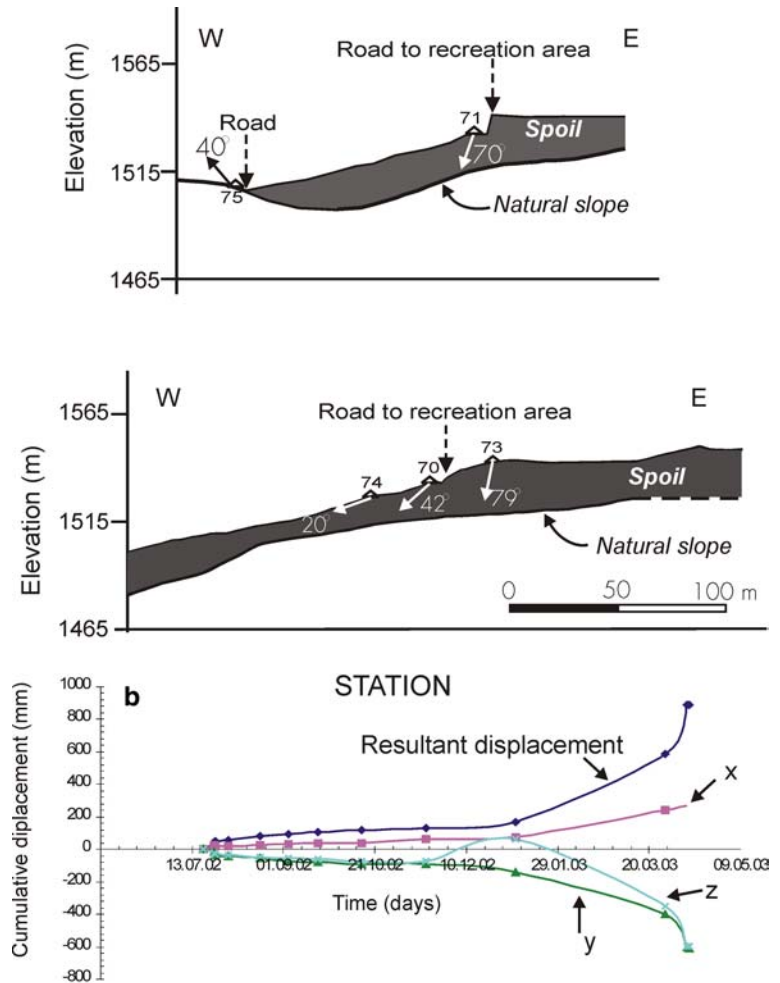
(INS2) were also evaluated and the resultant movement vectors are shown in Fig. 12a. The position of the tension cracks suggest that this movement was limited by the haul road to the east. However, based on the plunges of stations 71 and 73, a considerable amount of vertical deformation occurred on the road connecting the pit to the recreation area (70° and 79°; see Fig. 12a). As can be seen from Fig. 12a, direction of the resultant movement vectors indicate that the failure has probably initiated along a circular surface through the old spoil material near the road to the recreation area and then passed through the spoil or along the natural topographical surface beneath the dumps. The movement vector at station 75 displays an upward direction, and therefore, the location of this station can possibly be considered as the toe of the failure (see Fig. 12a). An example time

versus cumulative displacement graph from a station shown in Fig. 12b suggests that the movement accelerated, particularly in March 2003, and failure was completed at the end of March 2003.

Fig. 12 a Resultant movement vectors shown on the cross-sections, and **b** a typical cumulative displacement versus time plot from INS2.

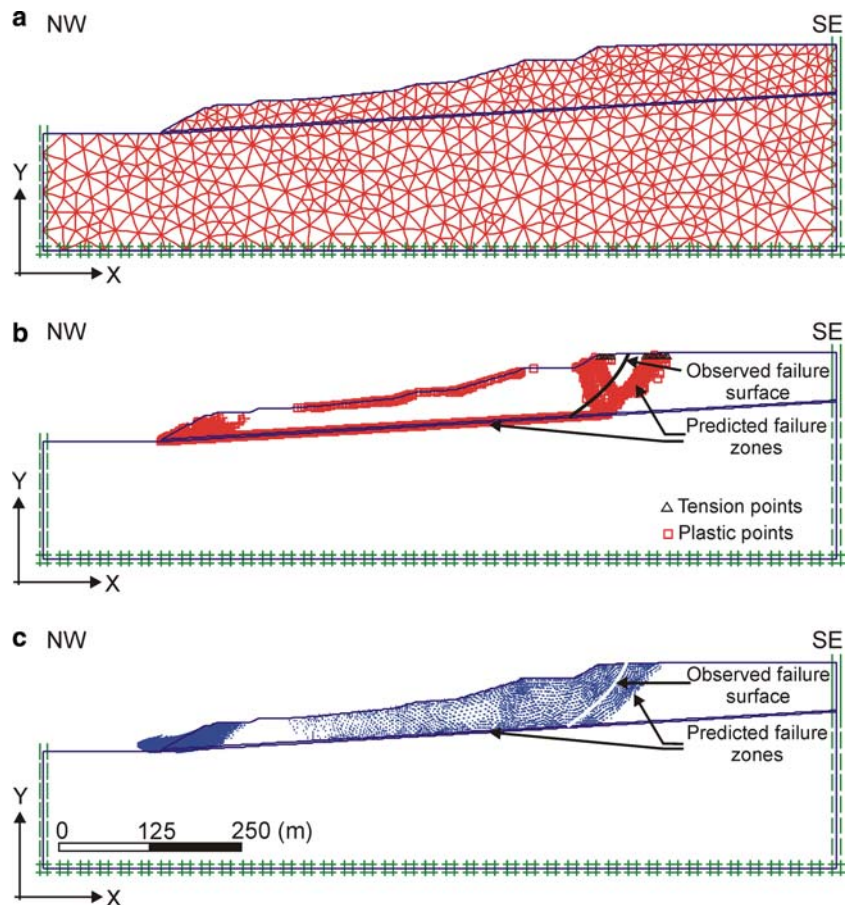
Fig. 14. **a** Finite element configuration and boundary conditions of the model along cross-section 1-1', **b** distribution of yield points and **c** calculated nodal displacements with the observed failure surface for instability INS1

Numerical analysis of INS1 was carried out on cross-section 1-1'. The geometry, boundary conditions, and finite-element mesh used in the numerical analysis are depicted in Fig. 14a. Nodal displacements were constrained to zero at the vertical boundaries of the mesh. In the analysis, r_u was taken as 0.26, which satisfied the limit equilibrium condition for the cross-section considered. Figures 14b and c display the yield points and displacement vectors, respectively, together with the observed sliding surface. As can be seen from Figs. 14b and c, the estimated failure zone from the FEM analysis is very close to the observed failure surface. In other words, plastic zones appear along the circular failure surface and the interface between the floor and the spoil piles. In addition, tension zones are in good agreement with the locations of the tension cracks observed at the crest of the instability. However, another plastic zone appears at the toe zone of the instability (Figs. 14b, c), indicating a movement at the toe of the dump. Based on the information from mine personnel, no separate movement was observed at the toe zone. This contradiction can be explained by two possibilities. Firstly, due

to fast rate of failure, a local movement at the toe could not have been recognized. Secondly, the r_u value used in the numerical analysis applies to the entire spoil, but the toe berm is relatively small, resulting in toe movement.
