## Assessment of environmental and engineering geological problems for the possible re-use of an abandoned rock-hewn settlement in Urgüp (Cappadocia), Turkey

**Keywords** Cappadocia · Environmental conditions · Kayakapi (Urgüp) · Rock fall · Stability of underground opening · Troglodyte · Tuff

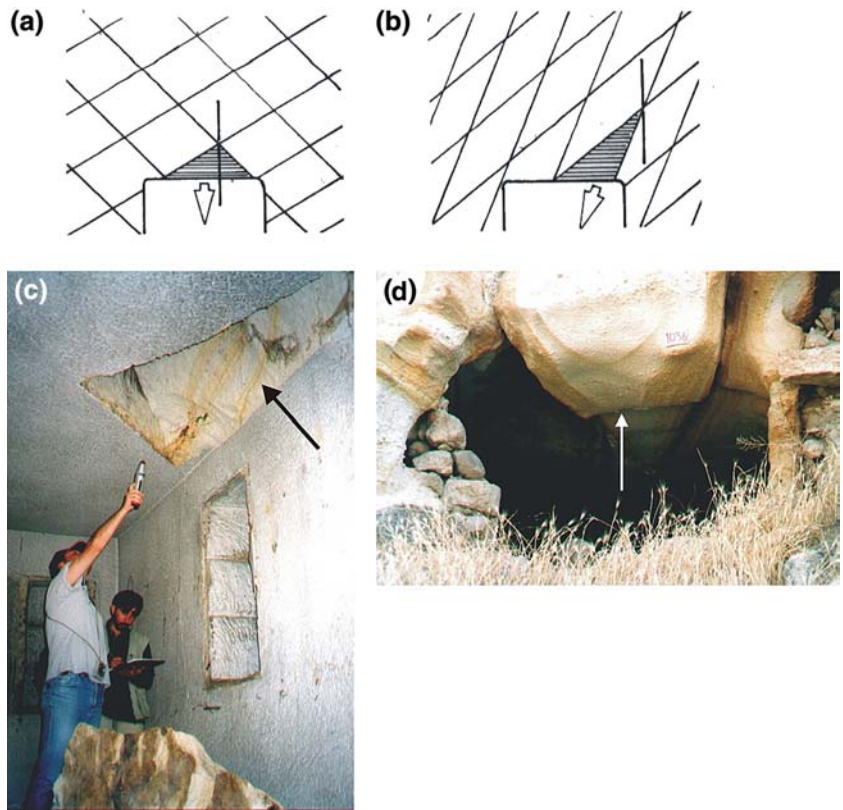
**Fig. 14** Conditions for gravity fall **a** and sliding failure **b** of roof wedges (Hoek and Brown 1980), **c** a wedge block that had fallen from the roof of an opening, and **d** a key block hanged at the entrance of a troglodyte at Kayakapi

intersecting discontinuities and fall under the influence of gravity or slide along the line of intersection of the discontinuities as illustrated in Fig. 14a and b. A typical block fall from the roof of an opening is shown in Fig. 14c. In addition, some hanging blocks, which have not fallen yet, were also observed on the roof or entrance of the openings (Fig. 14d). Such blocks can be considered as the key blocks and pose a threat to the long-term stability of the openings.

One of the methods to prevent structurally-controlled block failures is the supporting of roofs by timber beams as shown in Fig. 18a. This method is the traditional and commonly used roof supporting system in Cappadocia, and provides a good agreement with the original surrounding rock from the aesthetical viewpoint. The second alternative of roof supporting, particularly at the entrance of openings, is the construction of arches using prismatic blocks made of stronger tuffs. In addition, spalling can be minimized by removing the detached surfaces on the roofs and sidewalls of the openings. Although wire-mesh and shotcreting may be another alternative against spalling, the use of shotcrete may not be successful due to the inconsistent bonding between shotcrete and the rock itself and may not be suitable from aesthetical considerations.

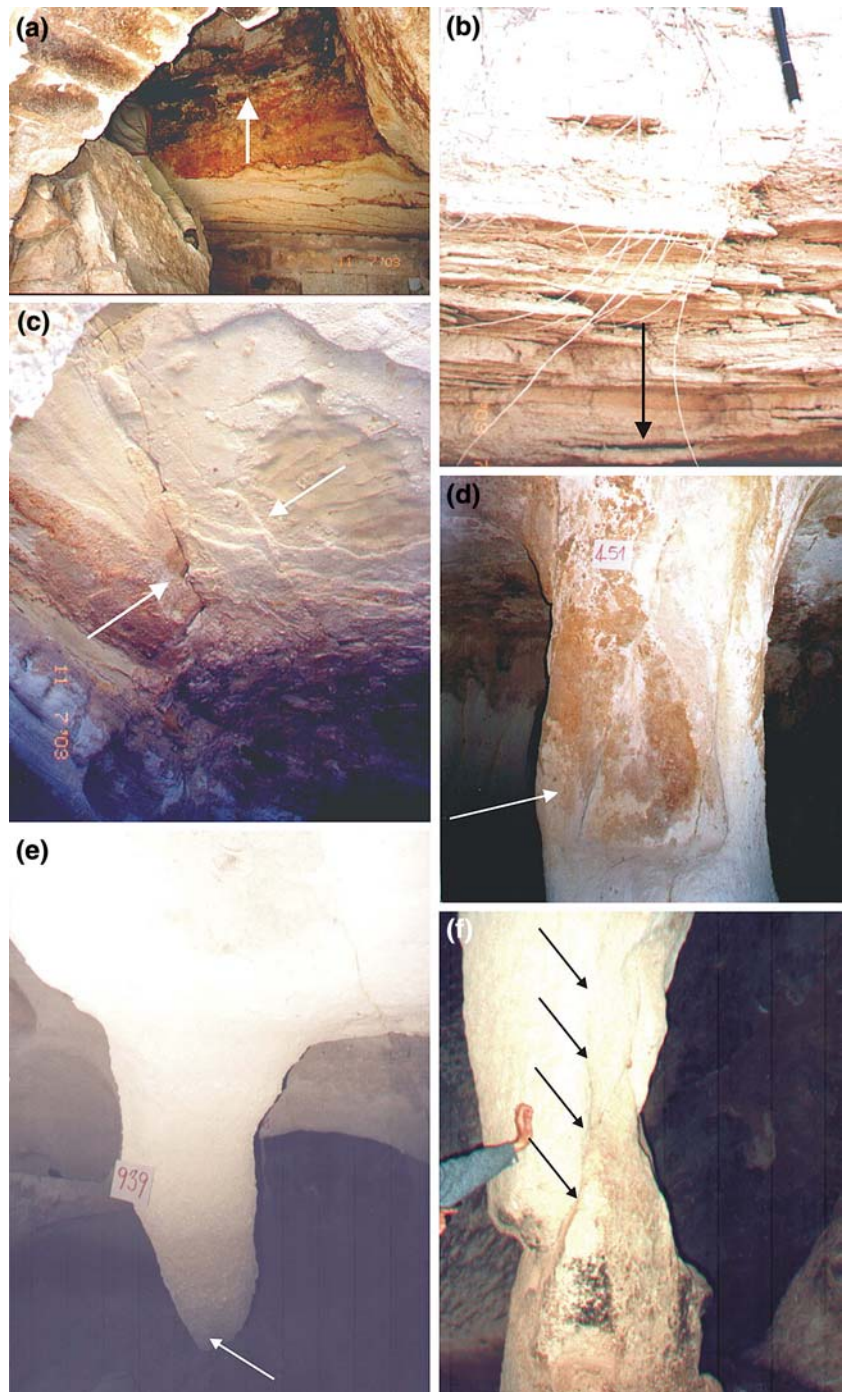
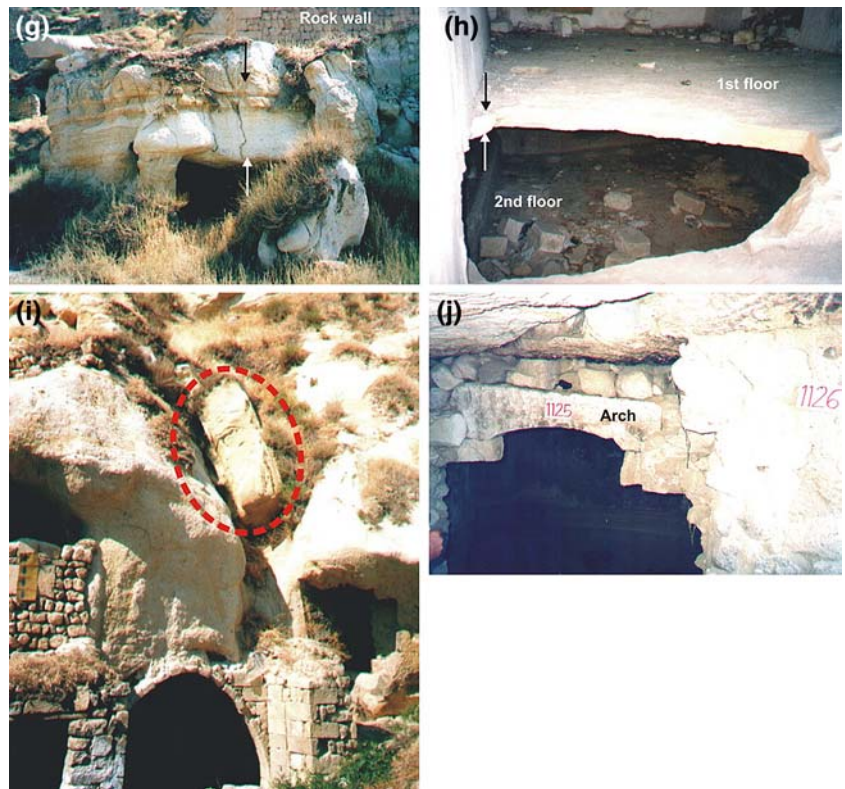
Horizontal or nearly horizontal stratification can be more dangerous where the beds dip  $5^{\circ}$ – $10^{\circ}$  and it may lead to roof overbreak. This instability problem is also commonly observed in the openings at the study site. The instability of the key blocks is followed by the deformation of secondary blocks resulting in an enlargement of the opening as seen in Fig. 15a. This instability phenomenon is also observed in the openings carved in thin-layered tuffites.

although the rock was not necessarily detached from the surrounding rock mass, the deformation caused fissures and hollows in the rock (Fig. 15b). In addition, some detached blocks of which bending strengths were exceeded due to bending fall into the opening.

Spalling is another local instability observed in the troglodytes at the Kayakapi Neighborhood (Fig. 15c). Spalling of exposed surfaces, due to alternate freezing–thawing and wetting–drying, is rather common.

In some large underground openings, a number of pillars have been left. Under the influence of atmospheric conditions and depending on weathering processes, some of the pillars tend to degrade and erode resulting in the loss of their supporting capability (Fig. 15d, e). In addition to this problem, due to weathering-induced partial loss of the pillar's strength and stresses acting on the pillars, shear cracks are also evident in some pillars (Fig. 15f).

**Fig. 15** Typical stability problems in underground openings at the study site: **a** overbreak, **b** bending, **c** spalling, **d** degradation, **e** erosion and **f** shearing of pillars, **g** effects of thin overburden and external load, **h** collapsed thin slab between the floors of a troglodyte, **i** a block with rock fall potential near the entrance of a group of openings, and **j** a weak arch at the entrance of an opening

In the study site, depending on the decrease in the thickness of the roofs, some instability problems such as collapse are observed at some locations, particularly in the openings which are located just below the main road or masonry structures (Fig. 15g). In addition, very thin slabs of about 10–15 cm between the floors

entrance. Although there is no stability problem associated with the surrounding rock in some openings at Kayakapi, due to the hilly nature of the site there exist some rock blocks which have fallen or rolled from higher altitudes near to the entrances of some openings (Fig. 15i). These blocks may fall due to any triggering factor, and therefore, special attention should be paid to such blocks.

Some pillars weakened due to degradation or cracking should be strengthened. For this purpose, such pillars may be surrounded by metal cages and the void between the cage and the pillars is filled by salt-free concrete. Then prismatic stones cut from the same tuff are laid down around the columns.

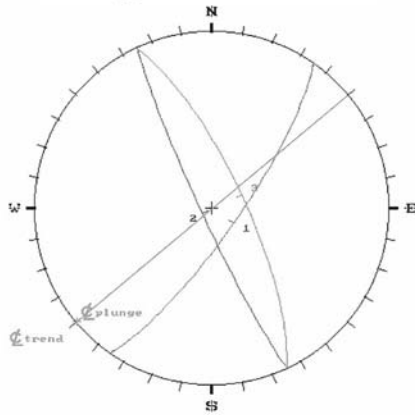
**(a) Troglodyte No. 123**  
**Joint sets:**  
 J1:78/125 J2:85/245 J3:75/065  
**Strike of the troglodyte:** 225  
**Width of the troglodyte:** 5 m  
**Type of failure:** Fall

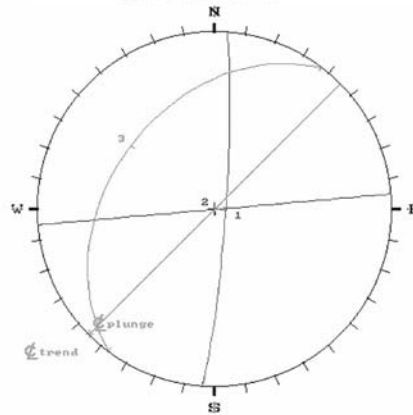
**(b) Troglodyte No. 411**  
**Joint sets:**  
 J1:85/094 J2:90/175 J3: 40/307  
**Strike of the troglodyte:** 230  
**Width of the troglodyte:** 4 m  
**Type of failure:** Fall

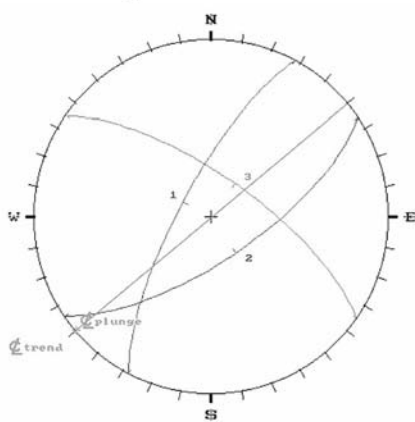
**(c) Troglodyte No. 1177**  
**Joint sets:**  
 J1:75/298 J2:70/146 J3: 71/035  
**Strike of the troglodyte:** 230  
**Width of the troglodyte:** 4m  
**Type of failure:** Fall

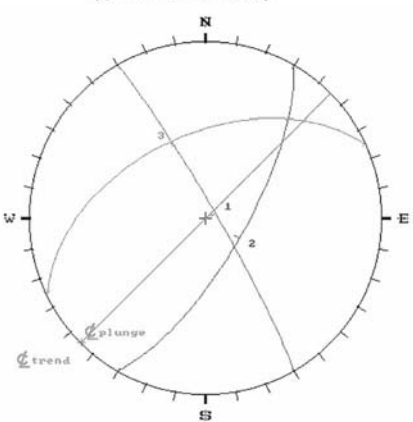
**(d) Troglodyte No. 118**  
**Joint sets:**  
 J1:85/060 J2:72/120 J3: 50/355  
**Strike of the troglodyte:** 230  
**Width of the troglodyte:** 5m  
**Type of failure:** Sliding

c (kPa)	$\phi$ ( $^{\circ}$ )	F
5	45	0.24
20	45	0.69
30	45	1.00

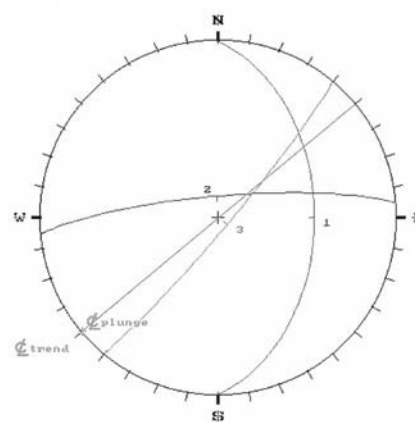
**(e) Troglodyte No. 1036**

**Joint sets:**  
 J1:48/090 J2:80/355 J3: 85/130  
**Strike of the troglodyte:** 230  
**Width of the troglodyte:** 3.65 m  
**Type of failure:** Sliding

c (kPa)	$\phi$ ( $^{\circ}$ )	F
0	35	0.6
0	45	0.86
5	35	0.87
10	35	1.17

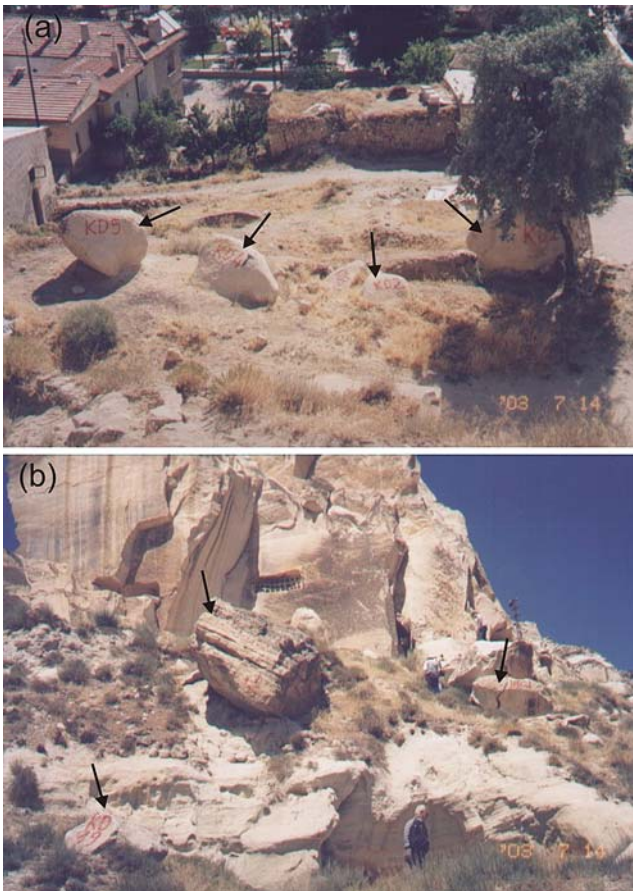
Fig. 19 The blocks that had already fallen at Kayakapi

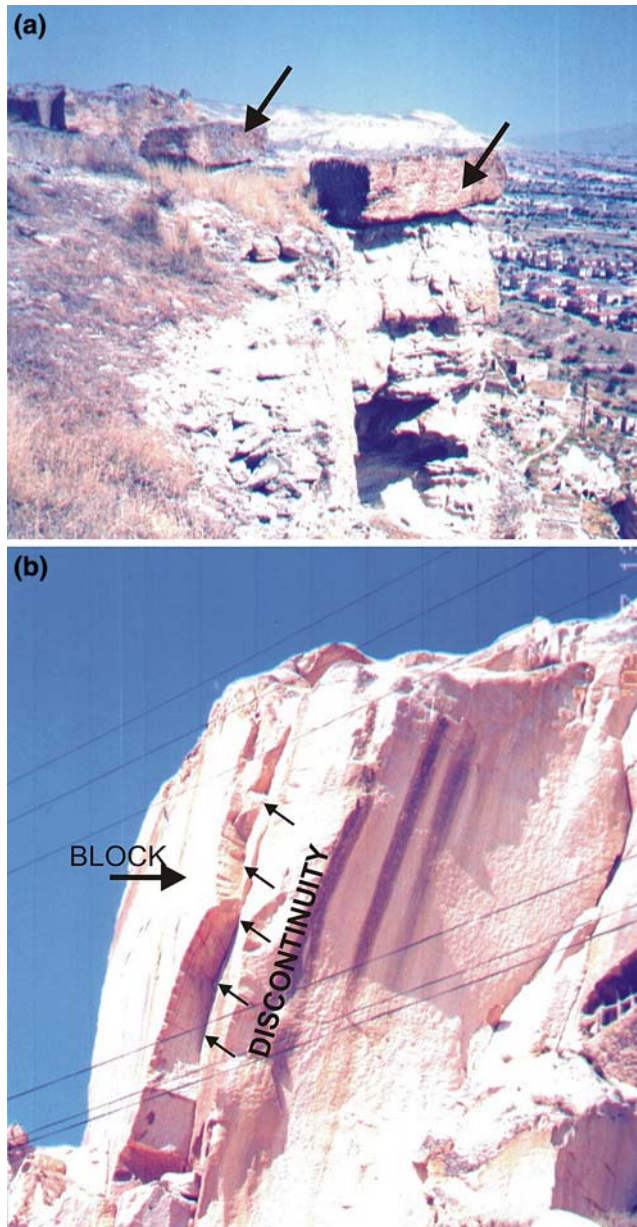
Based on field observations and rock fall analyses, the entrance of the Kayakapı called Büyük Kaya (Great Rock) is the most dangerous area (see Fig. 8). Many

**Fig. 22** a A block with rock fall potential resting at Esbelli Hill, and b a potentially unstable block needs bolting for stabilization at the entrance of the study site

identified blocks ready to fall in the study area (Fig. 22a) should be removed in a controlled manner. A retaining wall with a height of 3–4 m near the Büyük Kaya location covered with decorative local stones for aesthetic reasons may protect the entrance of the Kayakapı Neighborhood as a rock fall barrier. A large block (potentially unstable) already identified at the entrance (Fig. 22b) must also be stabilized with systematic rock bolting. No blasting should be allowed for the removal of the unstable blocks since it gives rise to widening of the cooling joints which adversely affect block stability. The blocks that seem to be stable at the moment may be unstable with the passage of time due to wetting–drying and freezing–thawing which are prevailing environmental conditions in the region. Therefore, they should be periodically checked.

In terms of rock fall potential, the area called Büyük Kaya (Great Rock) at the entrance of the site and its close vicinity is the most critical part of the Kayakapı Neighborhood. In addition to some already fallen rock blocks, there exist some other blocks with rock fall potential. In order to provide safety, both in this area and in the entire site, individual blocks should be broken into smaller pieces without blasting and then be removed from the site. Besides thick rock slabs on the face of a steep slope at Büyük Kaya location should be stabilized

by systematic bolting and a reinforced-concrete retaining wall with a gap behind should be constructed as a rock fall barrier. It is also noted that the long-term stability of the underground openings at the study site is open to further investigations by considering the time-dependent properties of the tuffs.
