# Collapse of caves at shallow depth in Gaziantep city center, Turkey: a case study

Hanifi Canakci

Received: 8 September 2006 / Accepted: 8 May 2007 / Published online: 25 May 2007  
© Springer-Verlag 2007

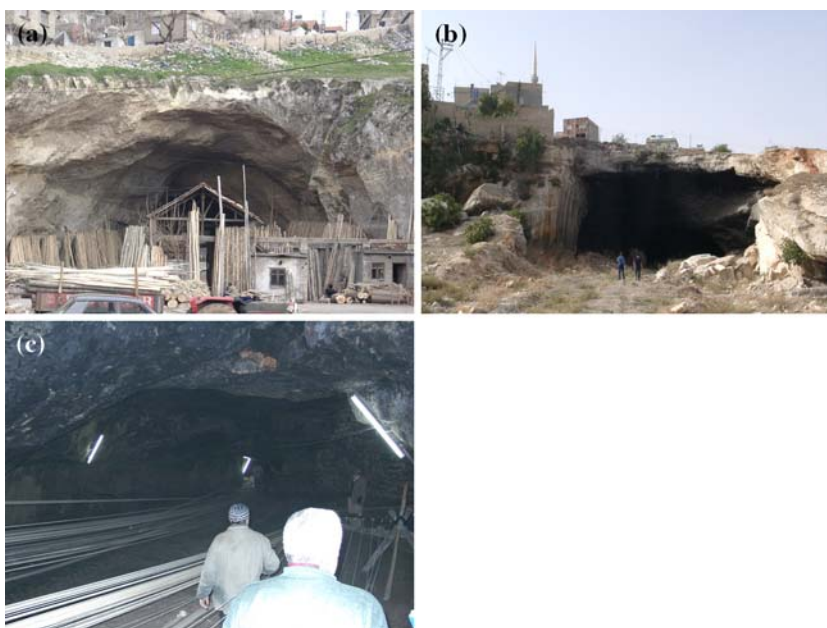
**Fig. 2** Caves in different locations of the city. **a** Cave used for wood storage. **b** Abandoned cave. **c** Cave used for yarn production

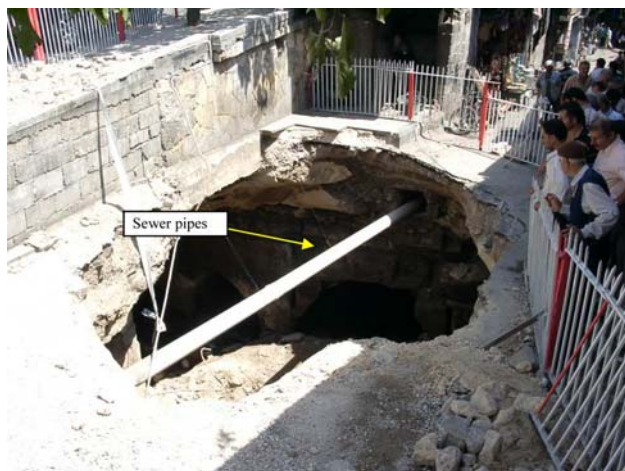
near the cave reported that the collapse occurred suddenly. Subsidence occurred in the pedestrian path connecting shops to the main street. The thickness of the roof of the cave was around 1 m and the width was approximately 8 m (Fig. 3). The collapse of the cave revealed a group of caves located nearby. The caves are located below a very busy street. There are also single and two-story houses, and shops over and around the caves. During the investigation, it was observed that water was leaking from the joint on the roofs of the caves. The bottom of the caves was full of water. Also, there were some cracks on a narrow gate connecting two caves. It was also observed that an older sewage system was passing across the roof of the cave as seen in Fig. 3. Some extension of the roots of live trees seemed to have caused fractures on the failed surface. A local shopkeeper also reported another collapse in the same

**Fig. 3** General view of the collapsed cave in Hamdi Kutlar Street

Investigation of the caves in Hamdi Kutlar Street also showed that the caves were full of water. This water most probably came from the leaking sewer pipes. During the examination of the cave, it was observed that water was leaking from the joint on the roofs of the caves.

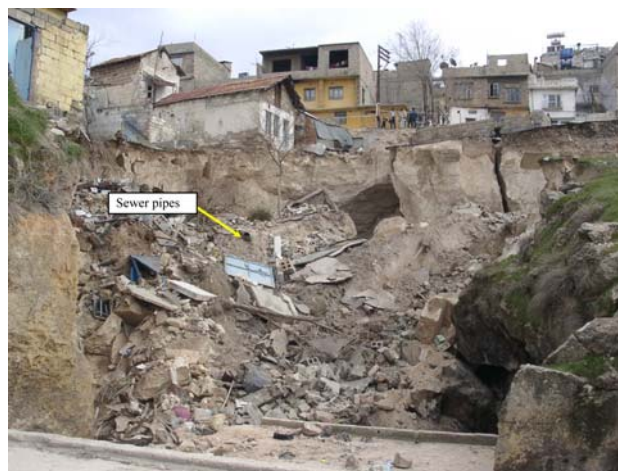
Another catastrophic cave failure occurred near Karakabir on the evening of 28 March 2003. The cave had been used for different purposes for a long time before it collapsed. The collapse was reported to have occurred suddenly. The roof thickness was around 3 m and its span length was approximately 15 m. There is a narrow road over the cave, which connects the surrounding houses. There are also single, two and three-story buildings over and around the cave (Fig. 4). As a result of the collapse, five houses were damaged. Five people living in those houses were injured and one person died. Some cracks occurred on the walls of some houses around the cave after the subsidence. Ten days before the failure of the cave, it had snowed heavily in the city. The thickness of the snow

**Fig. 4** General appearance of the collapsed cave near Karakabir

had reached 750 mm and it had remained on the ground for more than a week. Finally, the cave area was filled and rearranged as a park by the local authorities.

Inspection made after the collapse of caves showed that sewer pipes were buried in the roofs of the collapsed caves (Figs. 4, 5). Also, it was observed that the surface water drainage system over and around the caves was very poor. The failure of the cave in Karakabir occurred 10 days after a heavy snowfall. Thickness of the snow was around 750 mm and it remained on the ground for more than a week. The density of snow was measured 1 day after the snowfall and was found to be  $275 \text{ kg/m}^3$ . Snow acted as a distributed load on the roof of the cave and increased the stress on the pillars/walls.

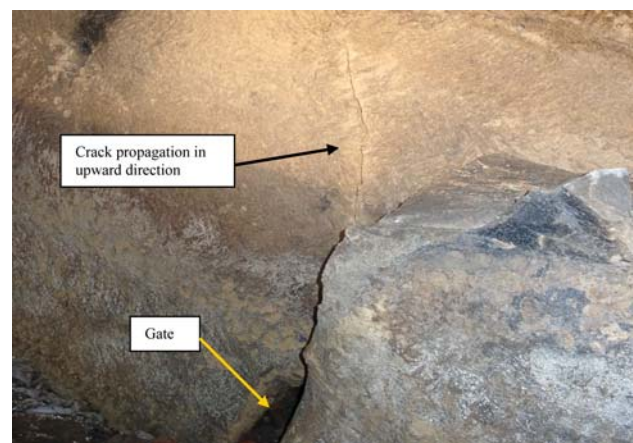
roof and the pillar/wall of the cave. Reduction in the strength of the rock due to saturation most probably accelerated the propagation of the cracks and initiated the collapse of the roof. There is a very good sign of this propagation of crack at the top of a small gate connecting the two caves (Fig. 6). This may be a sign of future failures of the remaining parts of the cave. It was not possible to investigate the discontinuities on the roof of the Karakabir caves, because it was filled a few days after it collapsed.

Fig. 6 Crack propagation at the top of the passage

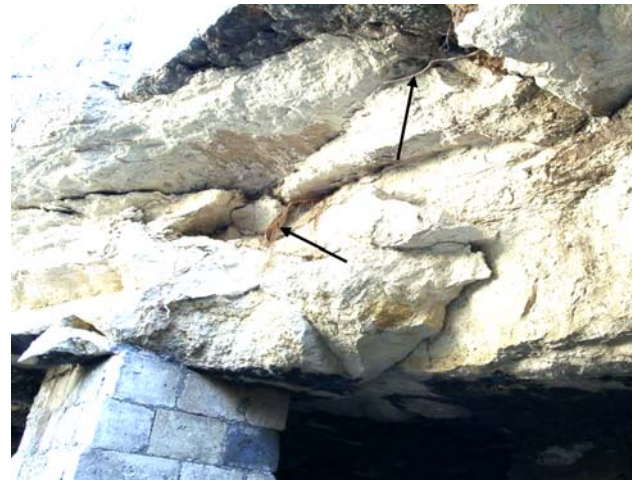
Tree roots may also be considered as one of the important factors that contribute to the failure of the caves. The roots appear to be fragile, but their appearance can be deceptive. The roots split the rocks and keep growing despite the tremendous weight of the rocks above them. Investigation made in the cave of Hamdi Kutlar Street showed that the roots of a tree penetrated into the cracks of the roof of the collapsed cave (Fig. 8). These roots probably weakened the rock by enlarging the existing cracks, which caused the reduction in the strength of the rock mass.

**Fig. 8** Roots on the roof of the collapsed cave in Hamdi Kutlar Street

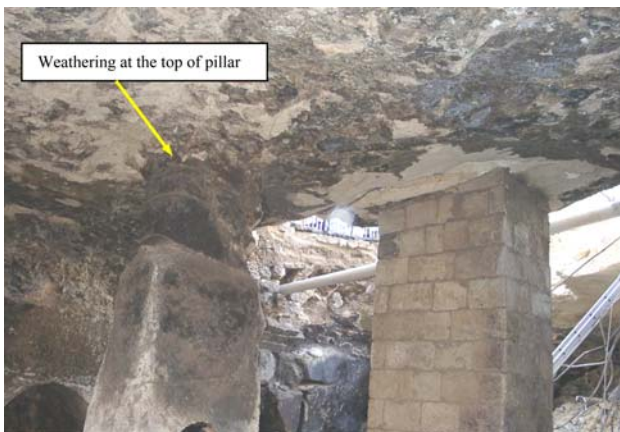
Weathering processes cause progressive changes in rock porosity due to changes in pore size distribution, pore geometry, pore connectivity, pore infilling and new pore formation (Tugrul 2004). Chemical weathering on the caves might occur due to the leakage of sewerage pipes. At the collapsed caves, it was observed that most of the original mass strength was lost. Limestone was discolored and the weathered part of the cave could be excavated easily by hand. All parameters showed that the limestone below the sewage pipes was highly weathered. The influence of weathering can be easily seen on the pillar in the cave (Fig. 7). The size of the pillar near the roof was reduced considerably when compared with its lower part.

**Fig. 7** Weathering of pillars of the cave in Hamdi Kutlar Street
