Some Observations of Landslides Triggered by the 29 April 1991 Racha Earthquake, Republic of Georgia

Article in *Bulletin of the Seismological Society of America* · January 1994

by R. W. Jibson, C. S. Prentice, B. A. Borissoff, E. A. Rogozhin, and C. J. Langer

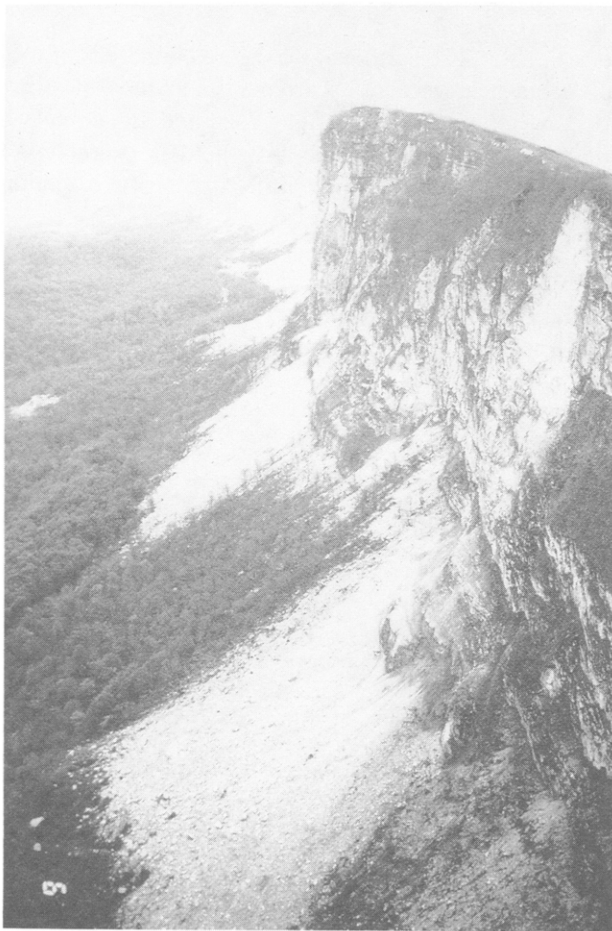
Figure 5. Limestone escarpment along Racha Ridge between Bokva and Usholta (see Fig. 3) that produced many large rock falls. Note fresh rock-fall deposit at base of scarp and fresh rock-fall scar at upper right. Scarp is more than 100-m high.

along Racha Ridge between Bokva and Usholta (Fig. 3), which produced several large rock falls (Fig. 5). The scarp is on the north flank of an anticline, and the limestone dips out of the escarpment as steeply as 40°. Joint orientation appears random, and spacing varies between 0.3 and 7 m; rock-fall source areas commonly are defined by intersecting joint surfaces. Some of these joints opened several centimeters as a result of the earthquake, which may have contributed to slope instability. The rock-fall deposits abut the scarp and form an almost continuous apron as steep as 55° along the base of the scarp. Individual rocks in the fresh deposits range from a few centimeters to 7 m across. Many of the larger blocks left prominent impact craters a few meters apart, which indicates very rapid movement.

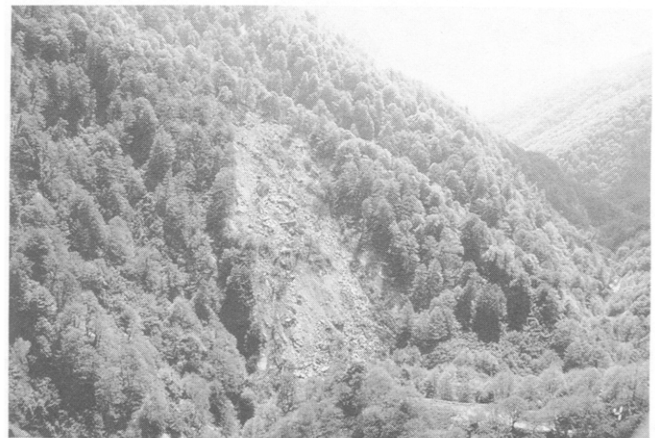
Figure 6. Typical debris slide in unconsolidated colluvium and residuum; slide is about 50-m long by 20-m wide.

Debris Slides. The earthquake also triggered dozens of debris slides, which typically are parabolic in plan view, on slopes steeper than about 35° along road and stream cuts (Fig. 6). Debris slides generally were confined to weathered volcanic bedrock and overlying colluvium or weakly cemented alluvium of stream terraces. Debris slides in the area range from a few meters to several tens of meters across and hundreds of meters long. Depths generally are about 0.5 to 4 m, but some debris slides are 15 m deep or more.

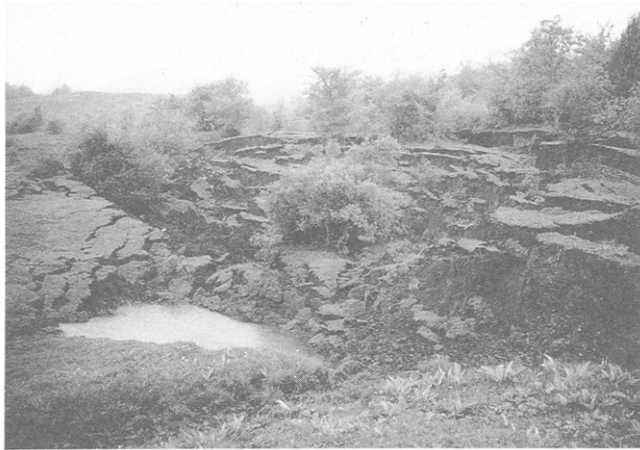
Figure 7. Complex part of main scarp of Zhaskva earth slide; total displacement is about 20 m. Note multiple scarps; deep, filled sag pond; and high degree of disruption of ground surface, all of which formed as a result of the earthquake.

Earthquake-triggered displacement along the main scarp ranges from a few decimeters, where scarp morphology is simple, to about 20 m, where the scarp contains multiple internal scarps, grabens, sag ponds, and extension fractures (Fig. 7). Many fractures near the scarp had standing water only 10 to 20 cm below the ground surface. The main scarp indiscriminately crosses several ridges and deep gullies, which indicates a very deep basal shear surface, perhaps 30 to 60 m.

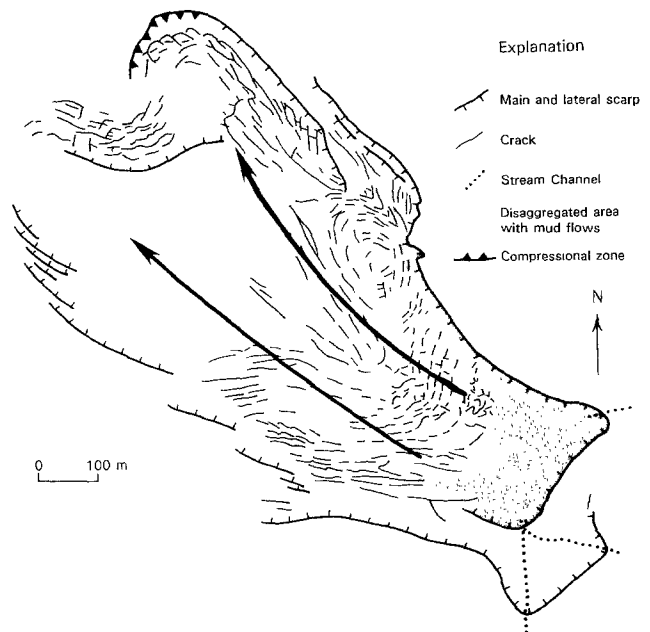
Figure 9. Sketch map of Chordi earth slide. Arrows show direction of landslide movement.

The Chordi Landslide. The second earth slide we investigated destroyed the village of Chordi (Fig. 3). This slide also is a reactivated feature in a valley underlain by claystone of the Maikop Formation. The slide is roughly rectangular in plan and averages about 500 m wide by 1000 m long and is 30 to 50 m deep; thus, the volume is 15 to 25 × 10⁶ m³ (Fig. 9).

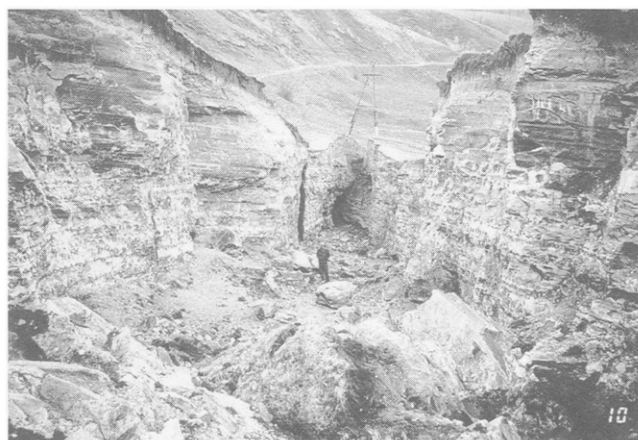
Figure 12. V-shaped gap between the main scarp (left side of photo) and the upper part of the Usholta slide block (right side). Man is standing on the basal shear surface, which dips 15° to the right. Note the decreasing displacement in the direction of view, consistent with rotation about a vertical axis. View is parallel to main scarp.

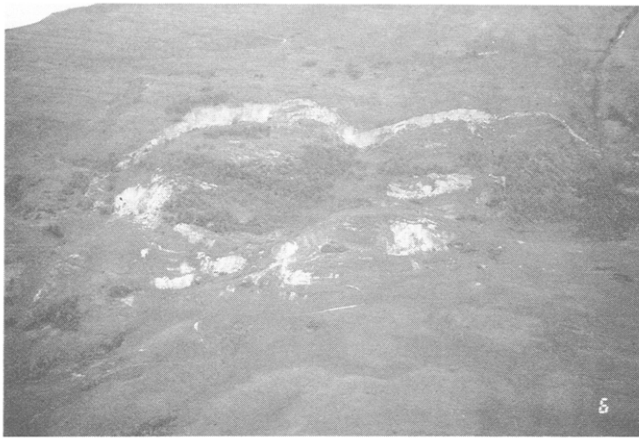
Figure 13. Rock block slide on slopes above Shkmeri. Landslide block rotated counterclockwise. Scarp on left side of photo has about 50 m of displacement.

Shkmeri. The earthquake also triggered a rock block slide on the slope above Shkmeri (Fig. 3); this dip slope also lies on the south flank of the anticline mentioned above at Usholta, where limestone bedrock dips 20° to 40° southward. The slide is about 625 m wide, 150 to 200 m long, and averages about 15 m thick; the volume is thus about $2 \times 10^6 \text{ m}^3$ (Fig. 13). The slide at Shkmeri is similar to that at Usholta in that it rotated outward from the original slope about a vertical hinge line located on the left flank. Thus, displacement is greatest along the right margin and decreases to zero at the left margin (Fig. 14).

The main scarp parallels the slope contour and undulates slightly. The maximum vertical height of the scarp, on the right side of the slide, is about 20 m. Downslope displacement also is greatest—about 50 m—on the right side. Scarp height and landslide displacement decrease toward the left end of the scarp, where the height is only about 1 m and the downslope displacement perhaps 2 m. The left margin is formed by an extension fracture that extends down a preexisting gully, narrows downslope, and ends just above the intersection of the left margin and the toe of the slide; this intersection marks the location of the vertical hinge line about which the slide rotated counterclockwise.
