## Observations of physical effects from tsunamis of December 30, 2002 at Stromboli volcano, southern Italy

**Abstract** On December 30, 2002, following an intense period of activity of Stromboli volcano (south Tyrrhenian Sea, Italy), complex mass failures occurred on the north-west slope of the mountain which also involved the underwater portion of the volcanic edifice for a total volume of about  $2\text{--}3 \times 10^7 \text{ m}^3$ . Two main landslides occurred within a time separation of 7 min, and both set tsunami waves in motion that hit the coasts of Stromboli causing injuries to three people and severe damage to buildings and structures. The tsunamis also caused damage on the island of Panarea, some 20 km to the SSE from the source. They were observed all over the Aeolian archipelago, at the island of Ustica to the west, along the northern Sicily coasts to the south as well as along the Tyrrhenian coasts of Calabria to the east and in Campania to the north. This paper presents field observations that were made in the days and weeks immediately following the events. The results of the quantitative investigations undertaken in the most affected places, namely along the coa

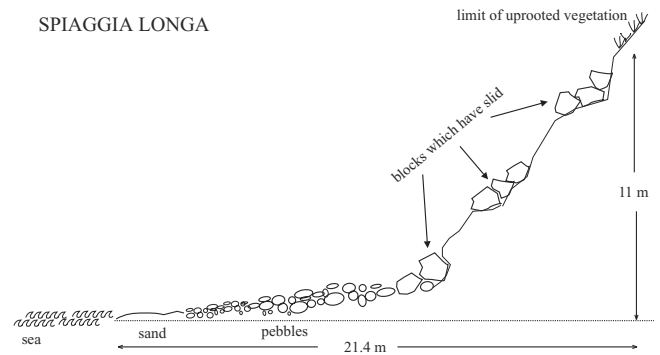
**Fig. 7** Topographic transect measured at Spiaggia Longa corresponding to the site where the highest runup value (10.9 m) of the entire survey was recorded. The path covered by the transect is sketched in Fig. 4 as a black solid segment connecting the coastline and the second measured point from the northwest

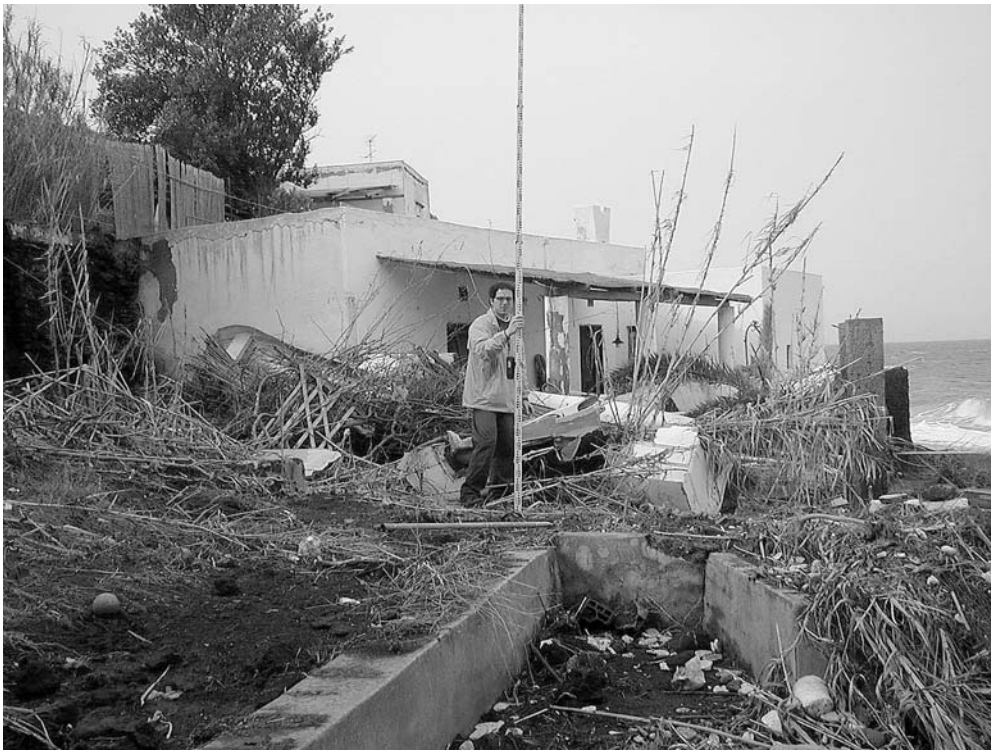
**Fig. 8** Flattened vegetation, small boats carried inland, and small walls toppled down as observed in one of the houses at the northwestern end of Piscità. The picture was taken during the first of three surveys (11–13 January 2003)

unhinged, windowpanes broken, sand deposited inside the houses and along the inner narrow streets, shrubs flattened, and small boats and other objects moved inshore (Fig. 8). In some houses, the water impact was so violent that furniture underwent a sort of “centrifugal effect” and was heaped untidily in the rooms.

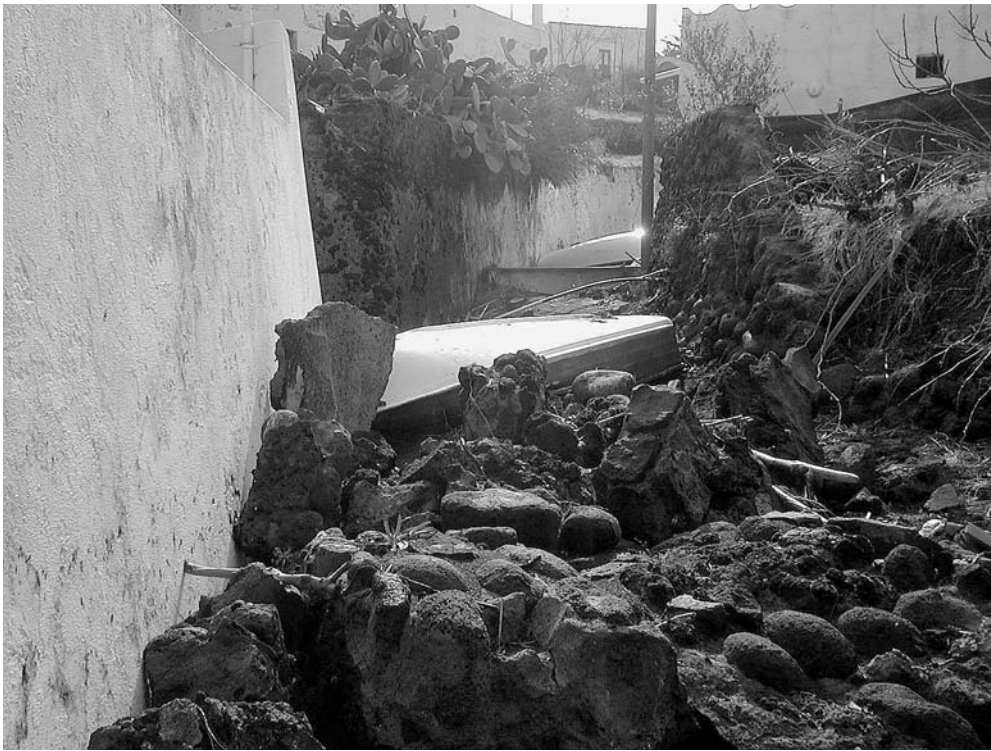
**Fig. 9** Photo showing small boats, broken walls and debris carried by the tsunami waves and channelled along one of the narrow streets of Ficogrande. The picture was taken during the second of the three surveys (21–23 January 2003)

lage buildings were almost completely uninhabited. Thus the impact of the water waves, which were particularly violent here, caused no fatalities. The damage produced by the tsunami was severe. Some small buildings were completely flattened, many walls were knocked down, including an inner wall in a house located about 5 m above sea level. A substantial amount of sand and pebbles was deposited in courtyards, terraces and inside the houses. Moreover, the tsunami moved every object it found along its path, including volcanic blocks, boats and scooters, and heaped everything in courtyards or along narrow streets and stepped paths (Fig. 9).

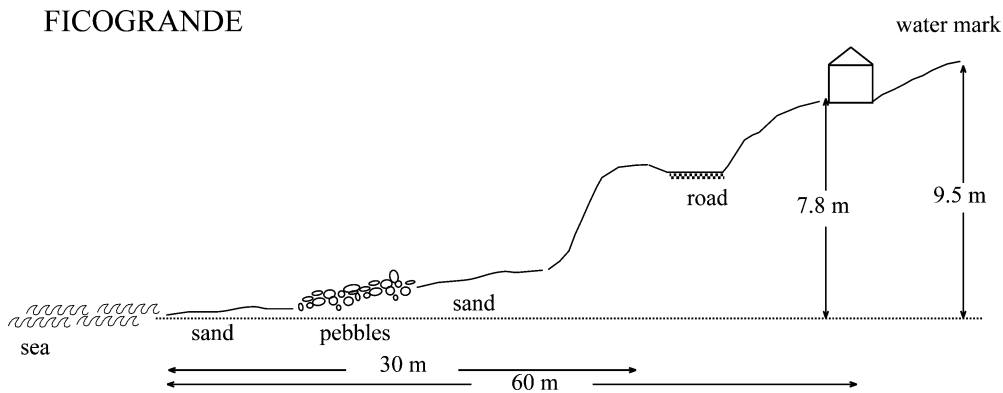
**Fig. 10** Detailed transect corresponding to the last houses at the eastern termination of Ficogrande

represented by a solid black line in Fig. 5 and is sketched in Fig. 10. The water waves climbed up the beach, overtopped the street, entered the terrace of a house where fresh sand deposits and damaged doors were observed (local runup equal to 7.8 m), then travelled through the backdoor of the house and continued to climb up the narrow street in the back to a height of 9.5 m above sea level. The horizontal extent of the transect was approximately 60 m.

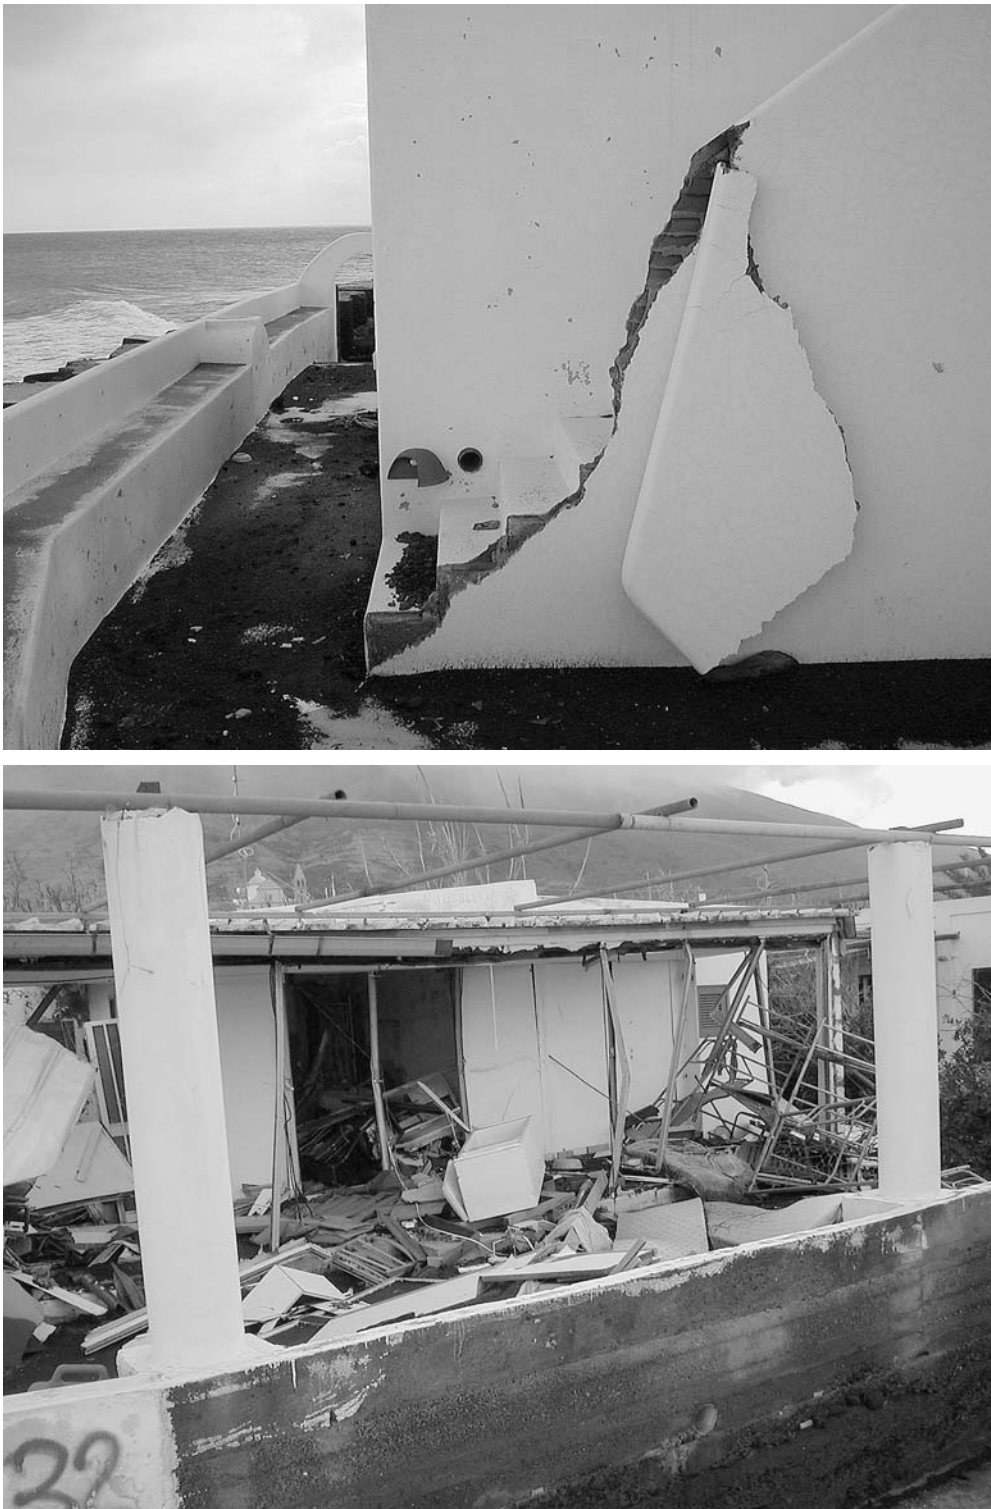
**Fig. 11** a Typical damage observed to holiday houses in Punta Lena which were built very close to the shoreline. The picture was taken during the second of the three surveys (21–23 January 2003). b Another typical view of damage produced by the 30 December 2002

tsunamis. Furniture is heaped inside and outside a house in Punta Lena. The picture was taken during the second of the three surveys (21–23 January 2003)

eral houses was heaped or ejected outside due to strong whirlpools (Fig. 11b).

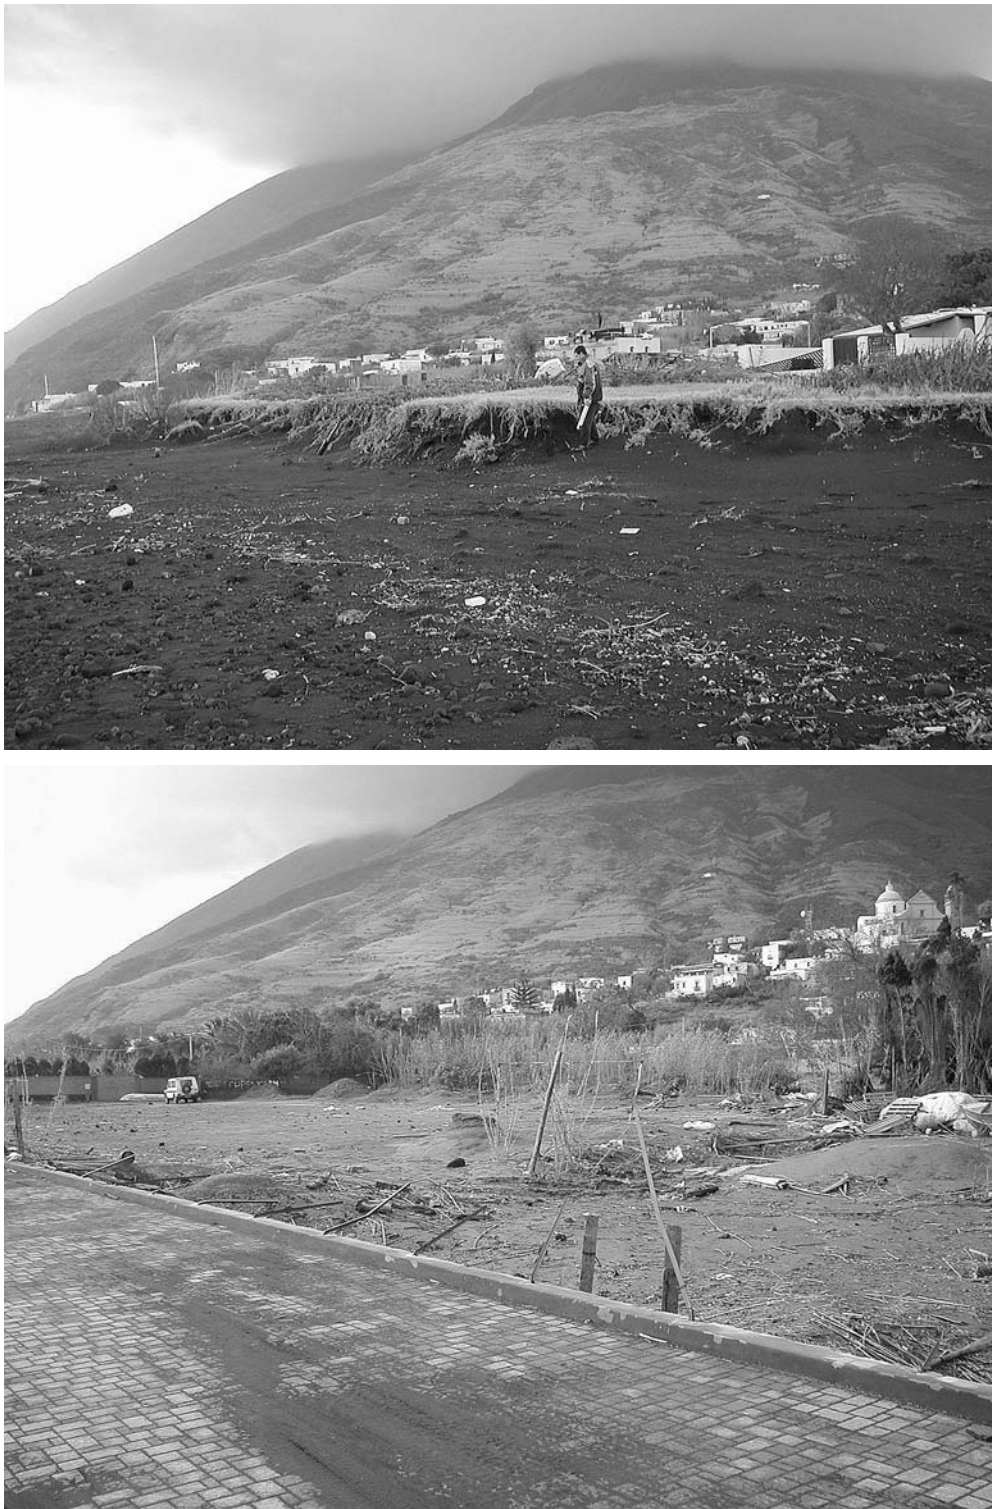
**Fig. 12** a Erosion effects observed along the Scari beach during the first survey (11–13 January 2003). b Fence bent by the tsunami along the portion of the main road running between Scari and Punta Lena. Picture taken during the first survey (11–13 January 2003)

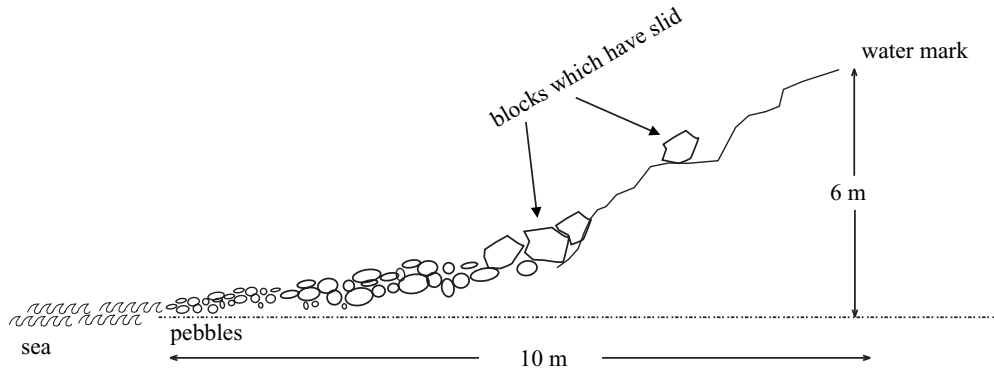
## LA PETRAZZA

**Fig. 13** Details of the transect surveyed at La Petrazza corresponding to the largest local runup measurement (6 m)

Along the stretch of coast south of the Scari pier, traces of the tsunami impact were not obvious. Very likely, the tsunami here was responsible for erosive phenomena associated with small landslides of the steep near-shore escarpments. In some places, watermarks were represented by uprooted vegetation or by huge blocks detached from the scarps. The measured runup values range from 1.5 to 6 m, with maximum ingression of about 22 m. The short white segment connecting the shoreline with the southernmost measured point in Fig. 6 represents the path of the transect corresponding to the highest runup elevation (6 m). Figure 13 illustrates some details of the transect itself.
