Failure and flow development of a collapse induced complex landslide: the 2005 Kuzulu (Koyulhisar, Turkey) landslide hazard

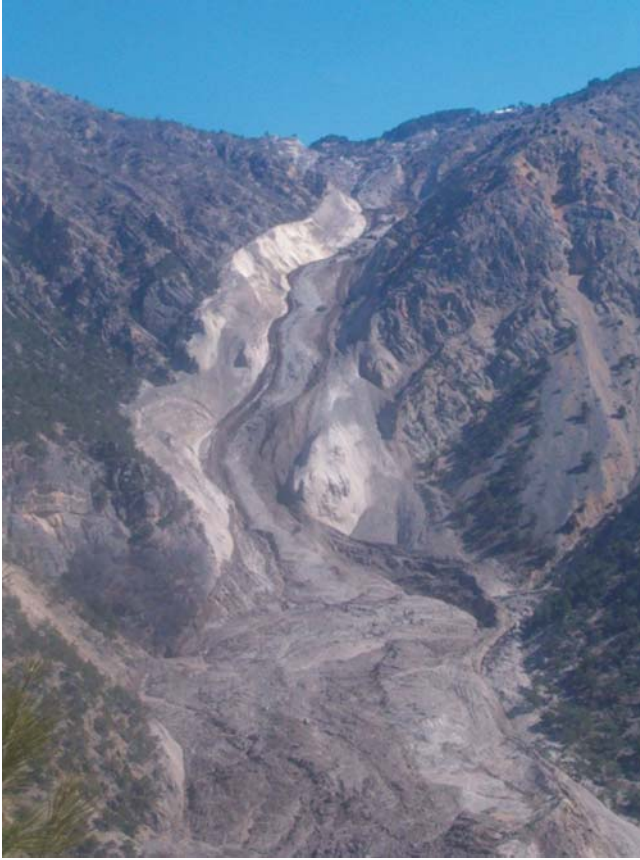
Fig. 1 A view from landslide

Kuzulu district. Landslide debris materials saturated with water were transported by the valley as a channel to the Kuzulu district, and settlement area was fully filled and covered by materials having an approximate volume of $10 \times 10^6 \text{ m}^3$ within $\sim 5\text{--}10$ min (Fig. 1).

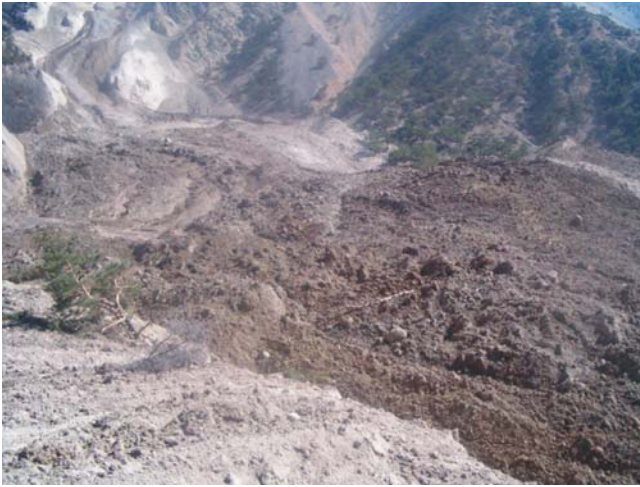
Fig. 5 Settlement area covered by debris material

by the valley as a channel to the Kuzulu district. Materials having an approximate volume of $10 \times 10^6 \text{ m}^3$ fully filled and covered the district within ~15–20 min (Fig. 5). So, the settlement area in Kuzulu district was named as “Disaster area”.
