Impact of water overexploitation on highland lakes of eastern Ethiopia

Tamiru Alemayehu · Wagari Furi ·
Dagnachew Legesse

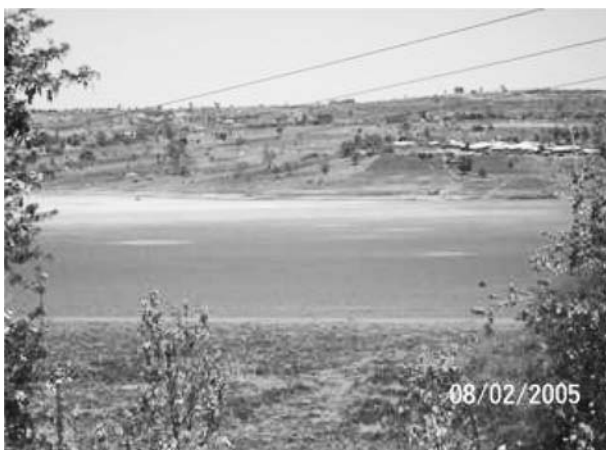
The current status of Lake Haromaya is shown in Fig. 2, where dead trees, bare soils and the absence of trees are the characteristic features that imply the consequence of the drying up of the lake and impact on the natural environment.

Fig. 2 The Lake Haromaya: dried up since 2005

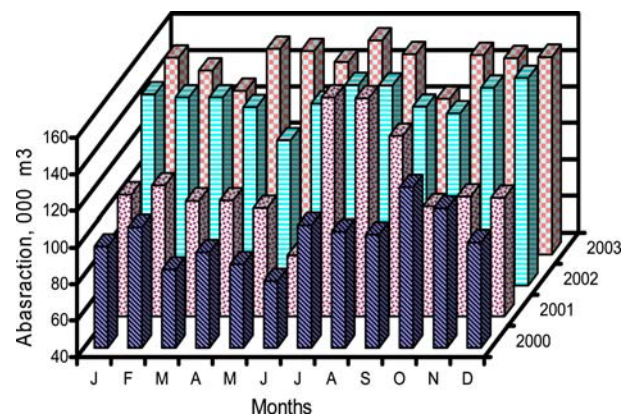
Fig. 3 Abstraction from the Haromaya Lake for drinking (000, m³)

The Lake Haromaya was the only source of water supply for the three big towns of east Hararge Zone (Harar, Alemaya and Awoday) as well as for the communities of the lakes region. Information from Harar town water supply office shows that the lake had been providing drinking water for a population of nearly 150,000 for the past 35 years. Initially the lake was abstracted at a rate of 35 l/s over 24 h a day for 25 years when the population was about 60,000. Later this rate was raised to 60 l/s in order to cope up with the increased water demand due to the increased population. The daily volume of water withdrawn from the lake for water supply (during the initial period of 35 l/s) was 3,024 m^3 /day with an annual abstraction rate of 1.1 Mm^3 /year. Similarly, the daily volume of water withdrawn from the lake during the later time with 60 l/s was 5,000 m^3 /day with an annual abstraction rate of 1.8 Mm^3 /year. Considering the first 25 years during which the lake was abstracted at a rate of 35 l/s, the volume was 27.5 Mm^3 and considering the later 10 years during which it was abstracted at a rate of 60 l/s, the volume was 18 Mm^3 with the total abstraction of 45.5 Mm^3 . The measured monthly abstraction pattern from the Lake Haromaya for 4 years is given in Fig. 4, which shows increasing trend in the past years. Due to the extensive water utilization, the lake level declined rapidly (Fig. 5), which had a water level of 8.5 m in the year 1975. For the comparison purpose, the exhaustion pattern of the Lake Adele is given in Fig. 6, which was dominantly used for irrigation and dried up in the year 2003.

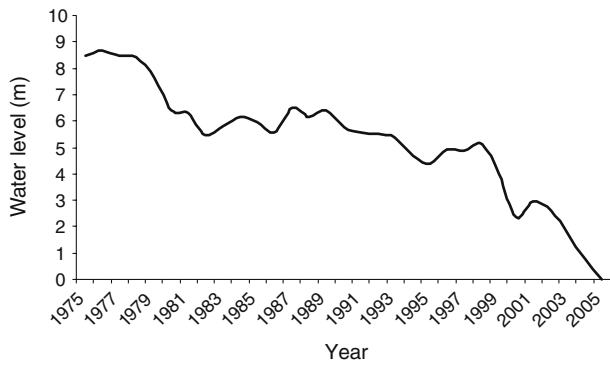
Fig. 4 Yearly mean lake level fluctuation for the Lake Haromaya: dried up in 2005

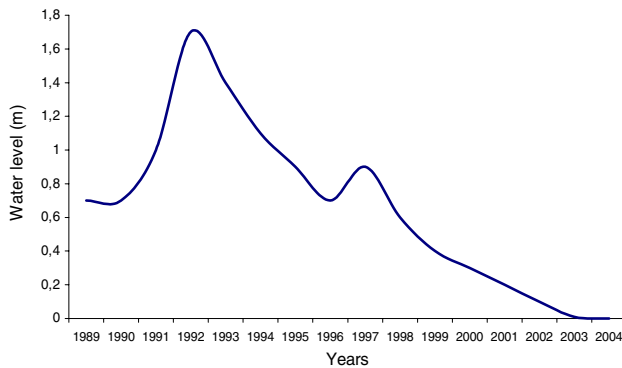
Fig. 5 Yearly mean lake level fluctuation for the Lake Adele: dried up in 2003

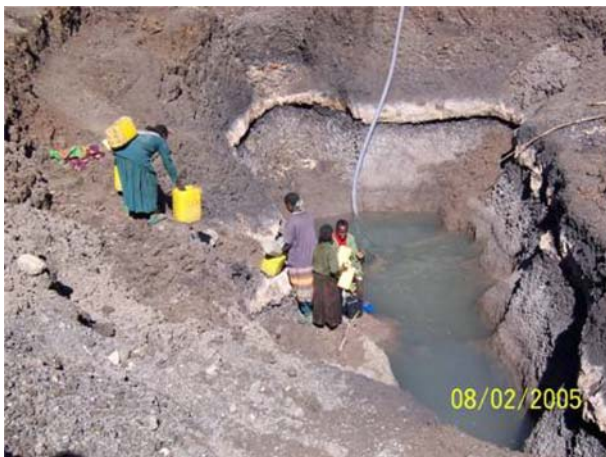
Fig. 6 Dug well at the center of dry lake basin. The water level is at the depth of 6 m

Currently due to the disappearance of the lake, for both drinking and irrigation, the local people excavate wide wells at the center and around the dry lake basin and pump water (Fig. 7). Such wells are quite unfriendly to the environment and are distributed all over the basin. All of the wells have wide opening with a depth that reaches 8 m. The local people also pump water from these wells for small-scale horticulture irrigation.

Haromaya. The wells operate over 24 h in unsteady state with variable yield (0.5–17 l/s). According to Furi (2005), the estimated overall abstraction from groundwater located in the unconsolidated aquifer is at a rate of 115 l/s, which is equivalent to 3.6 Mm³. Due to an unbalanced recharge with respect to the abstraction in the area, excessive groundwater pumping could invite the lake water, through hydraulic connection within the alluvial sediments, as a potential recharge and eventually reduce the lake water. Most of the boreholes are located within the close proximity to the lake and, therefore, the groundwater overdraft could be considered as supplementary and important factor for the loss of the Lake Haromaya. From field survey it has been observed from the open dug wells (Fig. 7) that the water level is located at about 6 m below the lake surface.

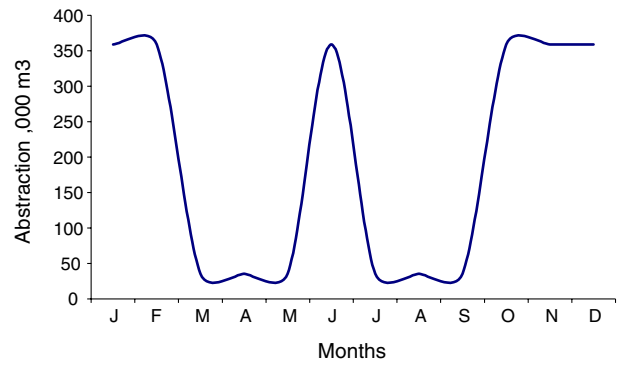
Fig. 7 Monthly mean abstraction from the Lake Haromaya for irrigation

6.65 Mm³. The general lake water abstraction pattern for irrigation is presented in Fig. 8 and it shows two extreme peaks characterized by seasonal pumping and abstraction decreases during rainy months (March, April, May, June). There is a large demand of water for irrigation by local people to irrigate vegetables all over the year.

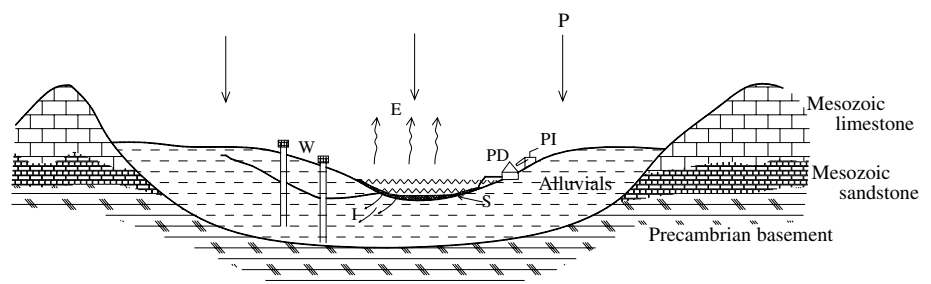
Fig. 8 Conceptual model for the parameters that constrained loss of the Lake Haromaya (*P* precipitation, *E* evaporation, *PI* pumping for irrigation, *S* siltation, *PD* pumping for drinking, *W* Boreholes, *I* Infiltration from the lake to the wells)
