Geology and hazard implications of the Maraunot notch in the Pinatubo Caldera, Philippines

A. M. F. Lagmay · K. S. Rodolfo · F. P. Siringan ·
H. Uy · C. Remotigue · P. Zamora · M. Lapus ·
R. Rodolfo · J. Ong

Received: 26 March 2004 / Accepted: 29 November 2006 / Published online: 5 January 2007
© Springer-Verlag 2007

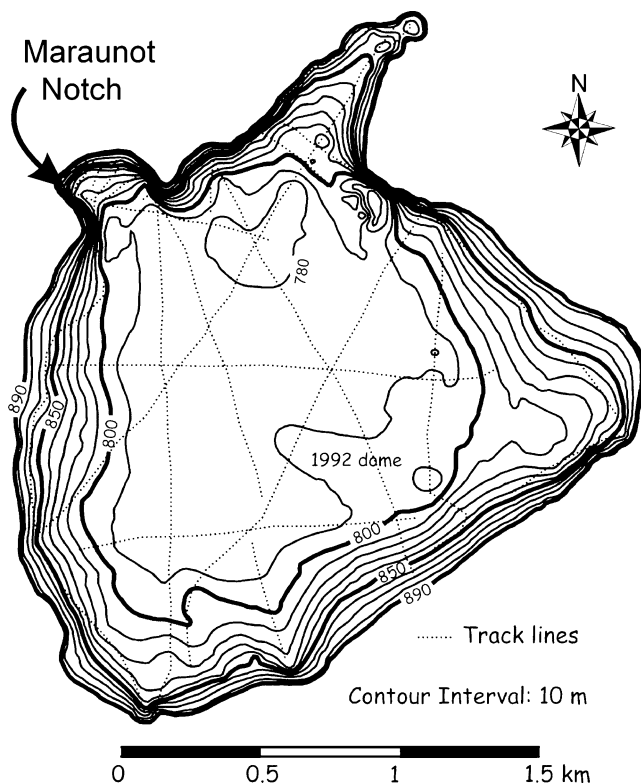
Fig. 2 Elevation contours of the caldera lake in 2003, from 15 km (dotted lines) of coupled sonar and GPS mapping

of the volume, based on bathymetry (Fig. 2) and caldera-wall geometry, is $1.61 \times 10^8 \text{ m}^3$. Thus, Pinatubo joined the 16% of the world's 714 active volcanoes that contain or have contained a lake in a crater or caldera (Simkin and Siebert 1994), and which accordingly pose the special hazards of large lake breakouts and the lahars they generate (McCall et al. 1992; Kusakabe 1996; Neall 1996; Varekamp et al. 2000). For students of this type of volcano, our study of the caldera, the geology of the breach in its rim, and events in 2001 and 2002 may be instructive.

After the breaching, $9.5 \times 10^7 \text{ m}^3$ of water, measured bathymetrically in 2003 (Fig. 2), still remains inside the caldera. The lake surface is slightly above the level of the physiographic sill at the Maraunot Notch and continuously drains along the outlet at an elevation of 890 m. Any event that raises the water level dramatically in a short period of time has the potential to generate another breaching event and dangerous lahars. Thus, knowledge of the notch geology is necessary for assessing and mitigating future lahar hazards at Pinatubo.

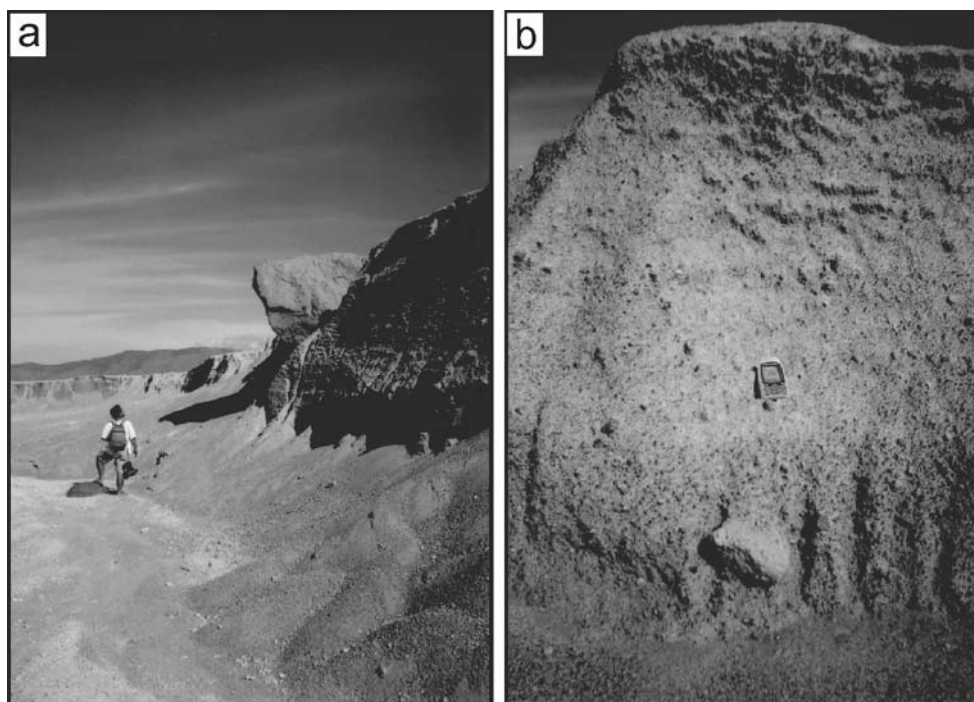
Fig. 3 Debris-flow deposits of the 2002 lake breakout of the Pinatubo caldera at the junction of the Maraunot and Balin–Baquero rivers (see Fig. 1b). **a** A large boulder sits at the top of the debris flow deposit; **b** Lithic and pumice clasts in a matrix-rich debris flow deposit. The outcrop is the same as in Fig. 3. For scale, the GPS unit is 10 cm long

flows from the 2002 crater lake breakout, and by assuming that the entire event consisted only of such, with a sediment/water ratio of 3/2, initially estimated their volume at $1.6 \times 10^8 \text{ m}^3$. That estimate is undoubtedly too low. Hyperconcentrated flows indeed were the only ones observed by scientists, but hours after peak flow, and less than 3 km from the Bucao River mouth. The 2002 breakout lahars left spectacular debris flow deposits in the Bucao and Balin Baquero valleys (Fig. 1b) 16–26 km from the coast, including single layers over 10 m thick (Fig. 3).

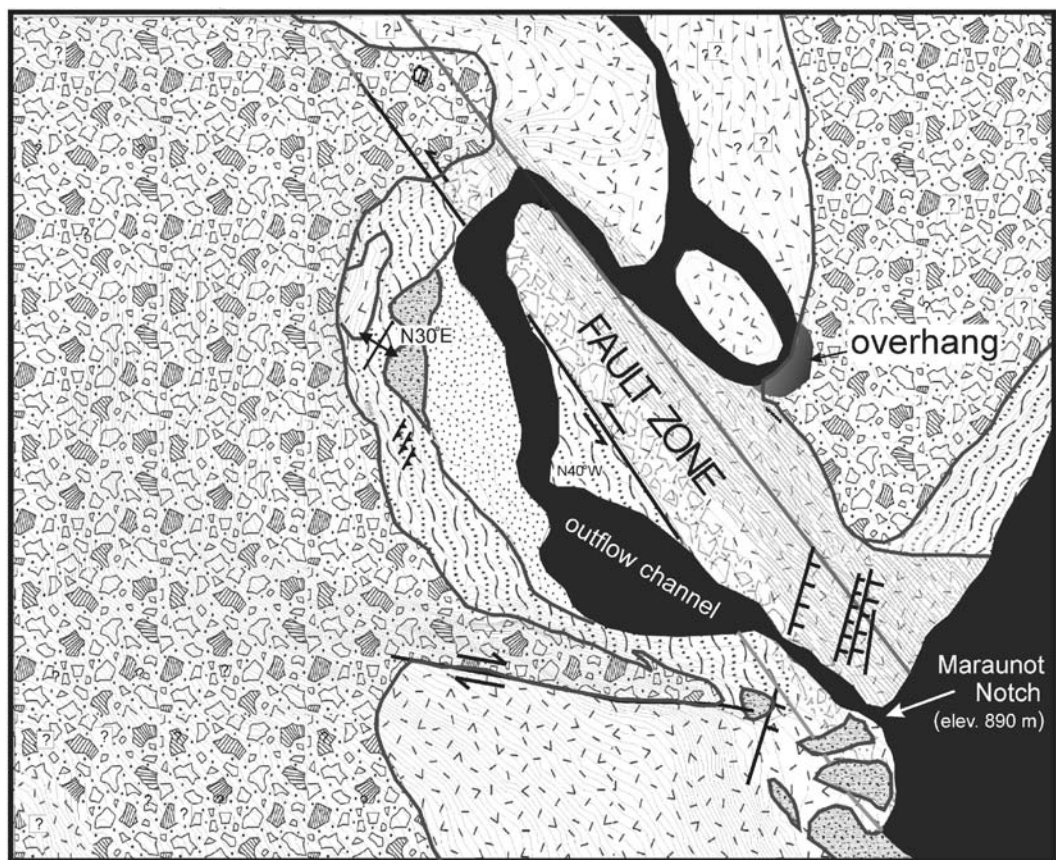
Geologic Map

Fig. 4 Geologic map of the Maraunot Notch area. The Maraunot Fault zone is oriented N40°W and is shown shaded over the contact between the lacustrine deposits and fault breccia. The position of the overhang in the second bend of the outflow is also indicated. Contours

near the channel below the second bend of the outflow have been manually interpreted. Mode I fractures have opening displacements perpendicular to the fracture surface

The rocks in the Maraunot Notch area are porphyritic andesite (fault-brecciated and sheared in part), intra-caldera lacustrine deposits, and volcanic breccias (Fig. 4). Porphyritic andesite (An_{50–60} contents) comprises the oldest and dominant rocks. Amphibole phenocrysts with seriate texture are also present. The phenocrysts dominantly range in size from 4–7 mm. The groundmass, comprising 60% of the rock, is glassy and contains fine-grained plagioclase laths, tabular amphibole, and accessory quartz. This dark gray porphyritic unit is massive but fractured, sheared and brecciated. Along the area of greatest fault movement, this rock is a well-indurated, monolithologic breccia with angular clasts that are self-similar in both megascopic and microscopic scales. Siltstone and sandstone dikes 3–6 cm wide intrude the breccia in stockwork fashion. The breccia is interpreted to represent brittle deformation in response to high strain during fault movement. Diminished strain eastward from the fault is evidenced in the porphyritic andesite breccia by decreasing fracture spacing, from centimeters to decimeters apart.

The Maraunot Fault zone is more than 15 m wide (Fig. 4) and consists of tight- and closely-spaced fractures in the porphyritic andesite and lacustrine deposits (Fig. 7). Left-lateral motion along the fault is documented by en-echelon tension gashes, slickensides, Riedel shears, thrust-faulting and left-lateral displacement of vertical beds. There is also apparent normal displacement of tilted beds (Fig. 8).

The channel downstream of the notch follows two sharp bends. At the second bend, the outer bank undercuts a wall in apparently fractured rocks and has created a prominent overhang, shown on the map in Fig. 4. As of 2004, the overhang had retreated about 10 m toward the caldera.

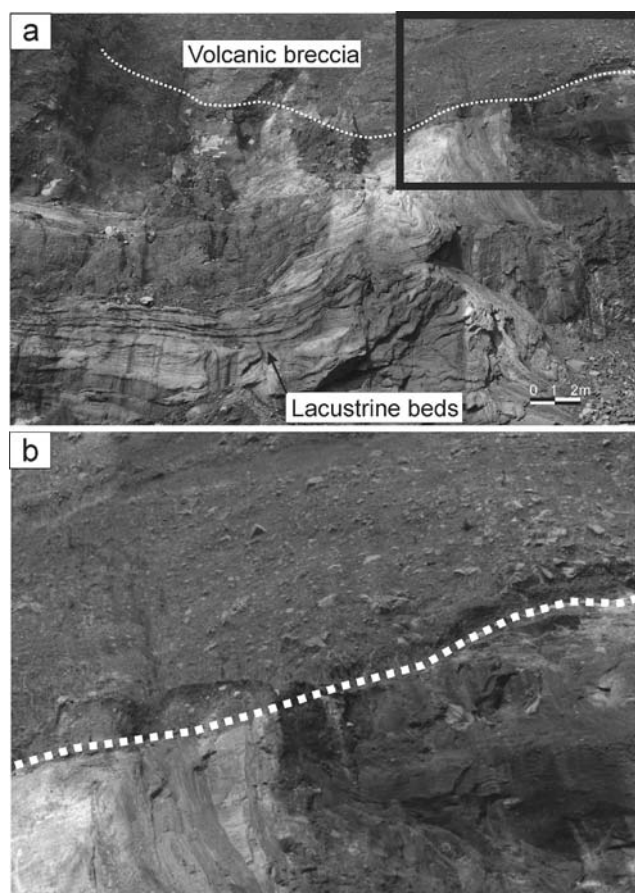
Fig. 5 a Deformed lacustrine deposits capped by younger volcanic breccia in the outflow region of the Maraunot Notch. An unconformity (white dashed line) separates the two lithologic units. Beds are flexure-folded and show associated reverse faulting in more competent beds that have undergone layer shortening. b Close-up view of the boxed portion in A

The lacustrine deposits are in fault contact with the porphyritic andesite and occupy the western part of the Maraunot outflow channel. Deformation obscured the relative ages of these rocks, but the lake deposits are sub-horizontal where exposed on the caldera wall near both sides of the notch. Had the lake deposits been older, they could be expected to have been bowed up when intruded by the andesites. About 20 m thick, this unit is composed of interbedded layers of well-sorted tuffaceous sandstone, siltstone and mudstone (Fig. 5). Bed thicknesses range

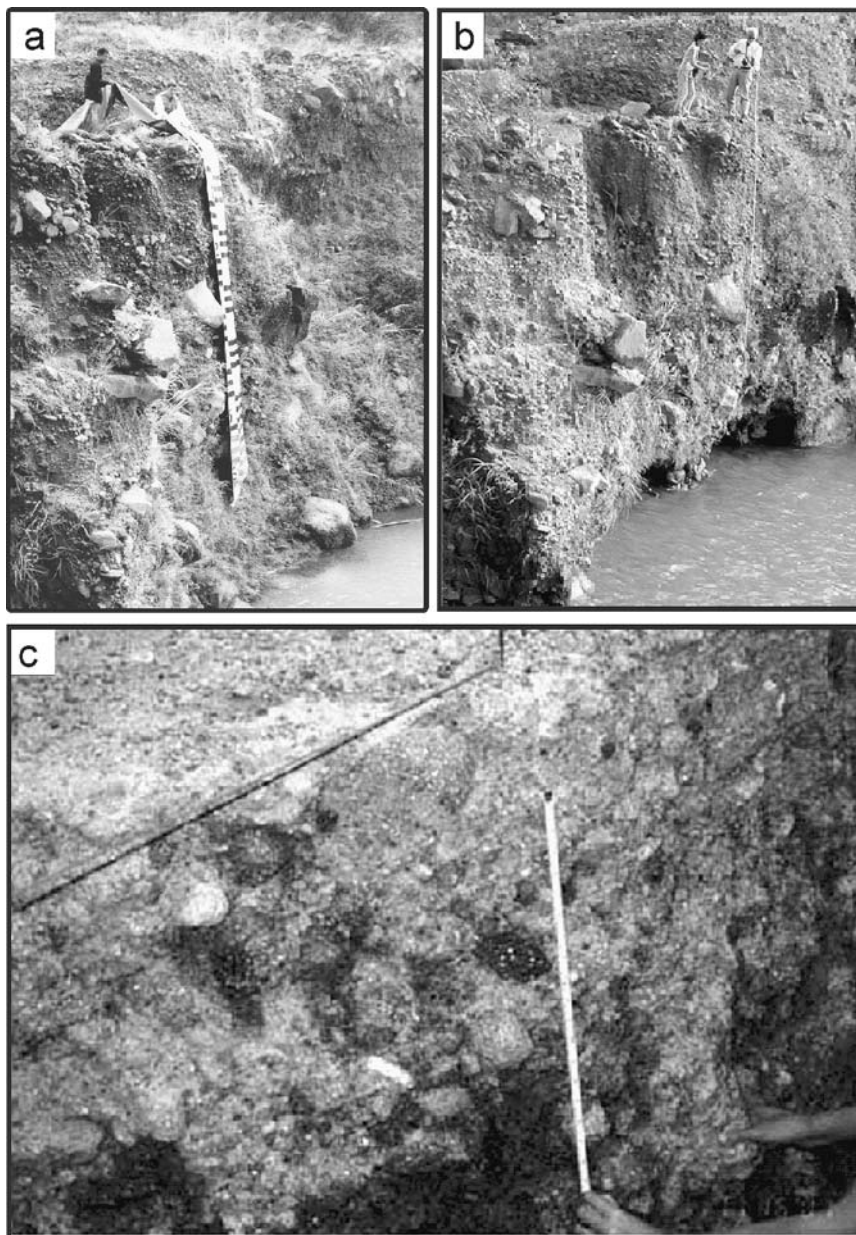
Fig. 6 The volcanic breccia at the notch before removal by the 2002 breakout. **a** A cliff during the rainy season on 30 July 2001; **b** The same cliff after the rainy season on 15 November 2001; **c** Close up of the breccia in the canal wall, 15 November 2001

Lying unconformably above the sedimentary deposits, a massive, poorly sorted breccia composed of angular volcanic blocks, crops out on the west side of the Maraunot channel. It apparently constituted the fill of an ancient channel, in the same general position as the 1991 Maraunot River headwaters that was removed by the 2002 breakout flood. It is matrix-supported, with clasts ranging greatly in size from less than 1 cm to about 1 m (Fig. 6). The

The volcanic breccia (Fig. 6) is most likely an old landslide that occurred when the volcano was higher, as indicated by its massive, chaotic, extremely poorly sorted texture, and the fact that boulders have no alignment such as parallel A–C planes or imbrication. Alternatively, the breccia may be a block-and-ash flow deposit, although no reverse clast grading or gas-segregation pipes were observed. A less likely depositional agent is debris flows, in which, however, the boulders would have tended to rise to the top because of dispersion pressure. Instead, the boulders are scattered fairly randomly throughout.

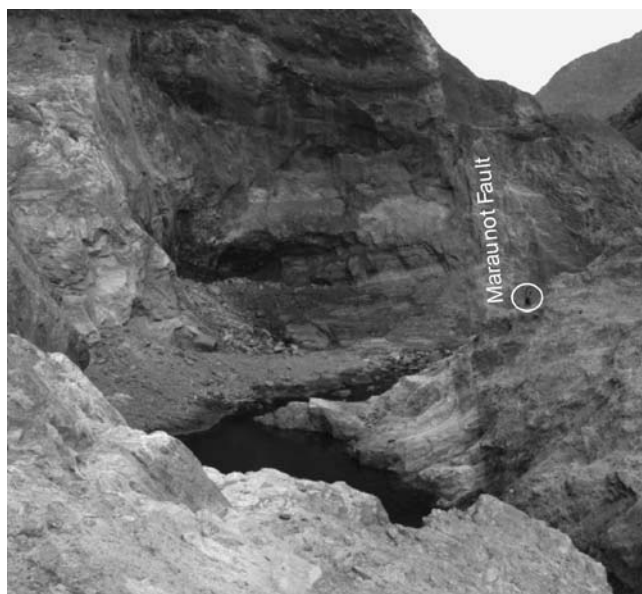
Fig. 7 Northwestward view from within the Maraunot Notch of a major slip plane of the Maraunot Fault, which trends N35°–40°W and dips steeply, separating the intra-caldera sedimentary deposits (*left block*) from the brecciated andesitic unit (*right block*). For scale, encircled is a man, 1.53 m tall, standing near the trace of the Maraunot fault at the *center, right portion* of the image

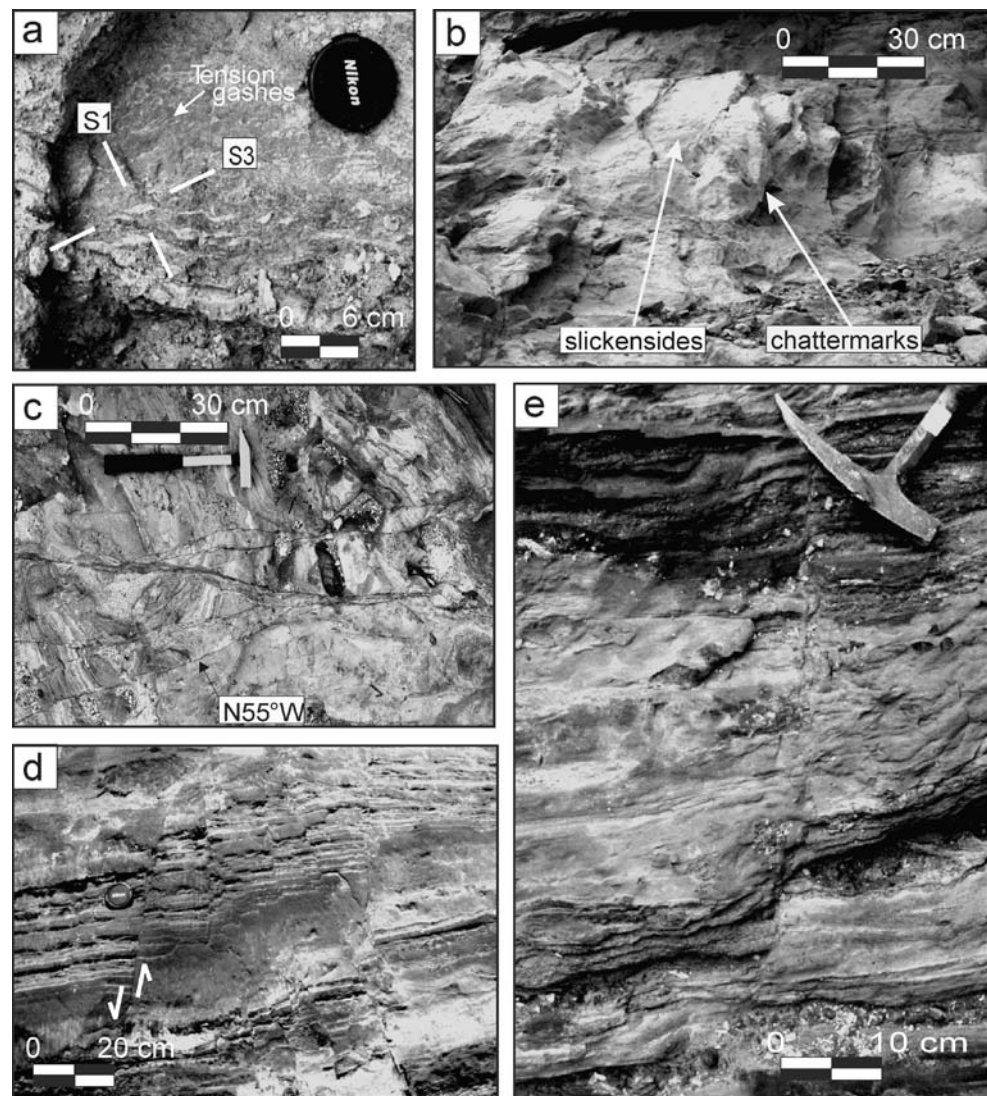
Fig. 8 Sense-of-motion indicators along the Maraunot Fault. **a** en-echelon tension gashes (*map view*); **b** slickensides in sedimentary tuffs (*profile view*); **c** riedel shears in sedimentary deposits (*map view*); **d** apparent normal faulting in strike-slip faults (*cross-sectional view* with beds dipping away from viewer); **e** left-lateral displacement of vertical lacustrine beds (*map view*)

The en-echelon tension gashes occur in the sedimentary tuffs, from which they are distinguished by their lighter color. In map view (Fig. 8a), they define the axes of

maximum and minimum stretch (S1 and S3), which define the sense-of-shear plane of the fault.

Slickensides are found in both the tuffaceous sedimentary deposits and sheared andesites. The orientation of the chatter marks and slickenlines in Fig. 8b indicate left-lateral strike-slip motion with a slight oblique-slip component. The maximum pitch is 15° to the south. Riedel shears on the sense-of-shear plane of the fault trend N55°W, at an acute angle to the main shear (Fig. 8c).

Apparent normal faulting can be seen in northwest-dipping beds cut by steeply dipping faults that strike northwest (Fig. 8d). This apparent normal displacement is due primarily to left-lateral movement and not from dip-slip motion. Vertical lacustrine beds are displaced left-laterally (Fig. 8e). Axes of fold structures, present only in the intra-caldera sedimentary deposits, generally trend N20°E. On the west side of the channel, a 20 m-high isoclinal, overturned anticline is bisected by a hinge fault that strikes N30°E and dips 80°SE. Microfolds are abundant and have the same geometry as the larger deformation structures. Thrust faults strike northeast through ash-rich beds of the intra-caldera sedimentary deposits.

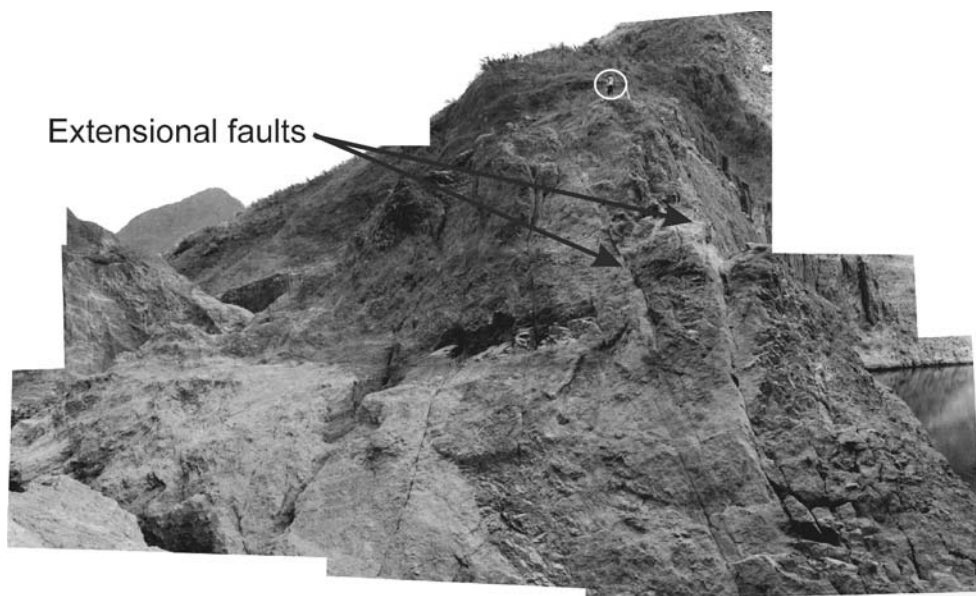
Fig. 9 Northeastward view of extensional faults parallel to the northwest caldera rim wall. The density of faults increase towards the caldera lake. For scale, encircled is a man, 1.53 m tall, standing at the top portion of the image, above the fractures

The northeast-trending set of fractures is extensional, with apertures of about 1–15 cm. They increase in density towards the caldera wall and dip very steeply to the southeast, towards the caldera lake (Fig. 9). These are probably normal faults associated with the caldera collapse of 1991. The east–northeast trending Tayawan Fault in Fig. 1c, mapped by Delfin et al. (1984, 1996), is located along the northwest caldera wall near the notch. This pre-eruption zone of weakness may have served as a locus of collapse faulting during formation of the caldera in 1991.

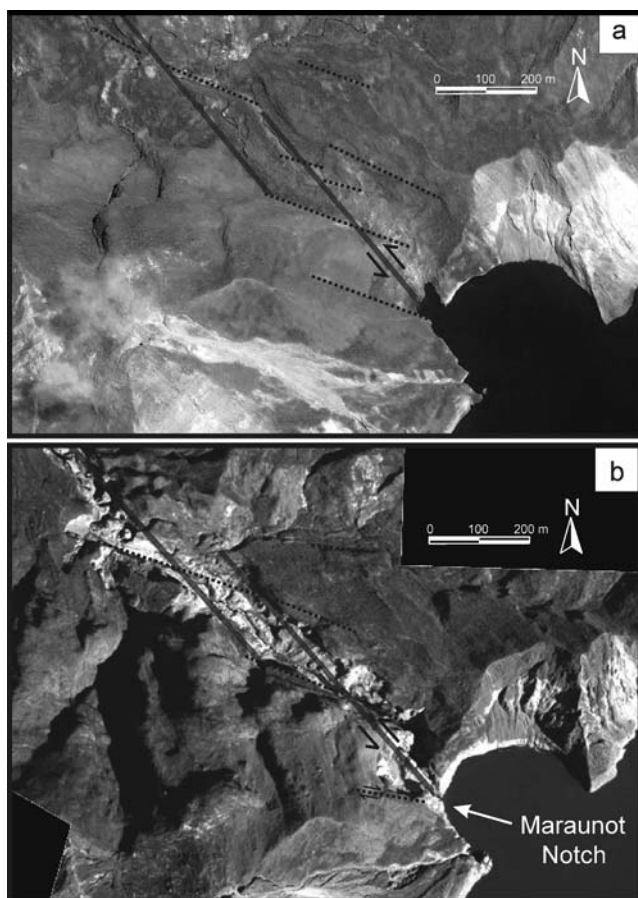
Fig. 10 Aerial views of the Maraunot Notch. **a** Before the 2002 breaching event, the traces of the riedel shears (*dotted lines*) of the Maraunot Fault (*solid heavy lines*) are evident in the Ikonos and aerial photos. **b** The post-breach image shows scouring of the river channel, coincident in part with the traces of the riedel shears in the pre-breach image

morphology and structural character of the northwest flank has been rendered even more obvious (Fig. 10b).
