# Use of geoprocessing in the study of land degradation in urban environments: the case of the city of São Carlos, state of São Paulo, Brazil

**Abstract** This paper presents a methodology for the geological engineering survey of land degradation in urban environments using both remote sensing and geoprocessing tools. The area under study was the city of São Carlos, state of São Paulo, Brazil (urban and expansion area). The data presented here were obtained from earlier studies, photo-interpretation and geological engineering mapping. The Envi 4.1 software package was used to prepare the digital orthophotos that served as a reference base for the information. Orthorectification of the Ikonos image (PSM, 1 m) was done and compared with other orthophotos from studies of environmental degradation in urban areas. The evolution of land degradation processes was analyzed based on the photointerpretation of aerial photographs taken on different dates and using Ikonos image. This study allowed to conclude that most of the degradation occurring in the city has been caused by unplanned land occupation, in disregard of environmental conditions, resulting in environmental degradation and thus

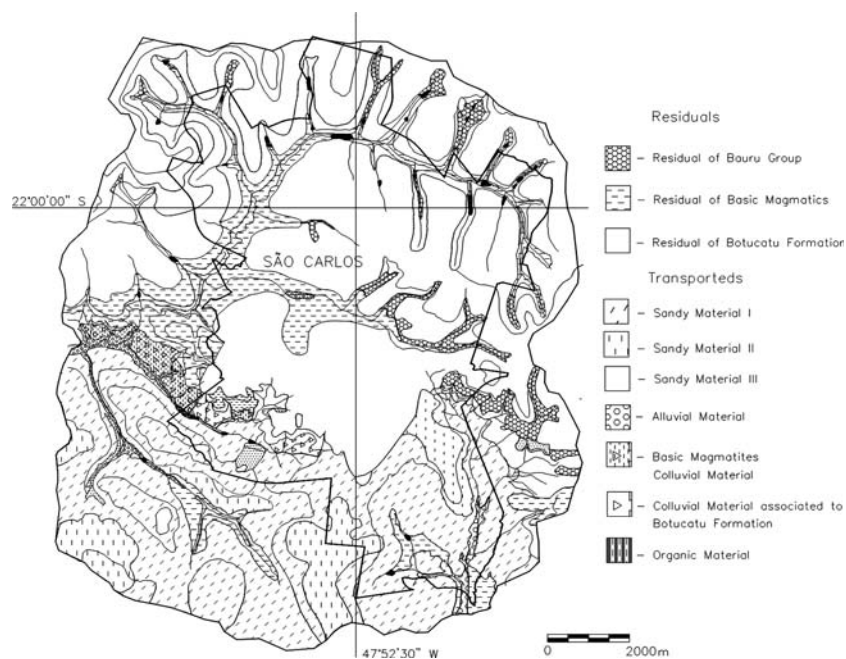
**Fig. 6** Unconsolidated materials map of the study area

A map of the unconsolidated materials (Fig. 6) was compiled from the same previous works that underpinned the map of the geological substrate, allied with the data taken from pedological maps, photointerpretation, and fieldwork.

The units of unconsolidated materials can be divided into two major sets in terms of their textural aspects, i.e., a sandy group associated with or originating from the rocks of the Botucatu and Itaqueri formations and another, clayey one corresponding to the areas of influence of the basic rocks of the Serra Geral Formation. In addition to this

broad division, the materials were also compartmentalized according to their genesis into residual and transported materials and into individual areas with different thicknesses and greater or lesser sand content within the group of sandy materials.

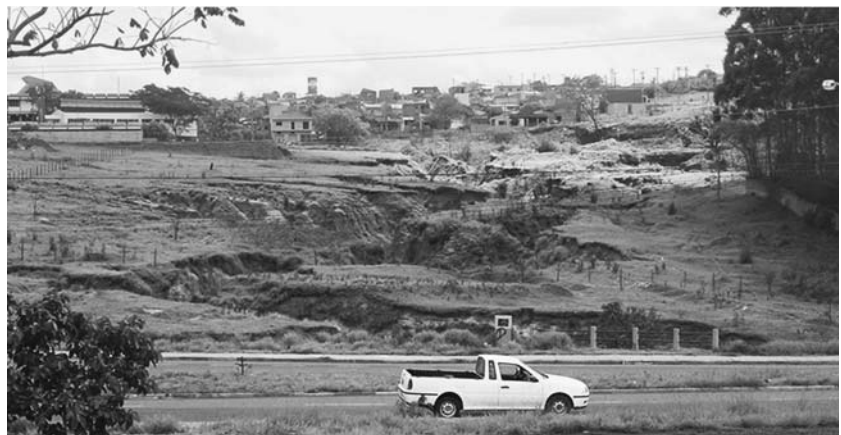
**Fig. 8** Gully erosion in the region west of the city, stabilized with erosion control constructions. Unconsolidated material unit that occurs in this area: sandy material I

In São Carlos, the areas with the most critical erosion correspond to 60% of the total area in the process of erosion. The gullies are associated with both unconsolidated sandy materials from the Botucatu formation and with the predominant classes of declivity (5–10 and 10–15%). Figure 8 shows a gully formed as a result of the improper installation of land parceled into lots in the western region of the city, which did not take into account the characteristics of the physical environment. In this case, the erosion was controlled by a drainage works, but the area was not recovered and poses risks to the surrounding population.

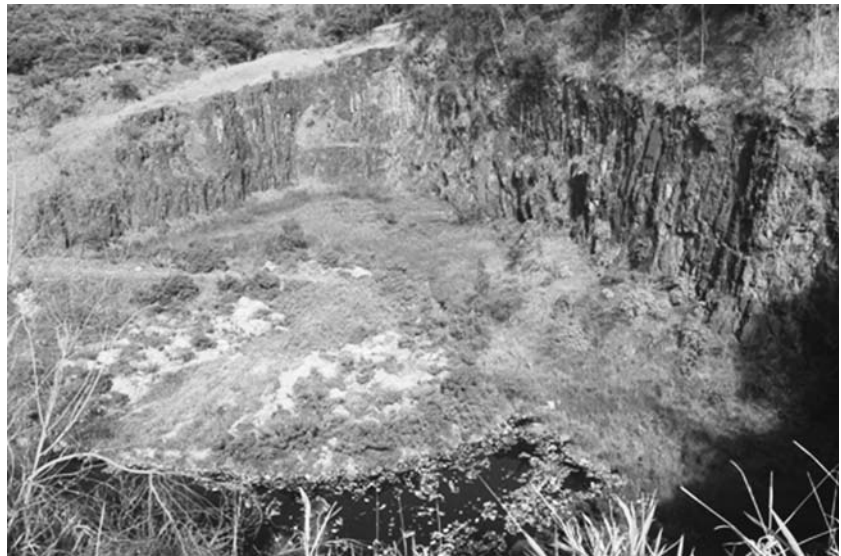
**Fig. 9** Abandoned quarry in area of basic magmatites of Serra Geral formation

The abandoned mining sites are situated mostly west of the urban nucleus, where the presence of the Serra Geral formation and important drainage ways for the city were observed. The absence of recovery plans increased the vulnerability of the physical environment, which has become subject to problems resulting from improper use, such as garbage dumps. The occupation of these sites may become subject to block collapses. Figure 9 illustrates the mining site abandoned due to encroaching urban occupation that has spread in that direction. Note that the area poses risks due to its high declivity, the existence of a lake approximately 8 m deep and the easy access to the site, which has led to cases of fatal falls, according to information from local residents.

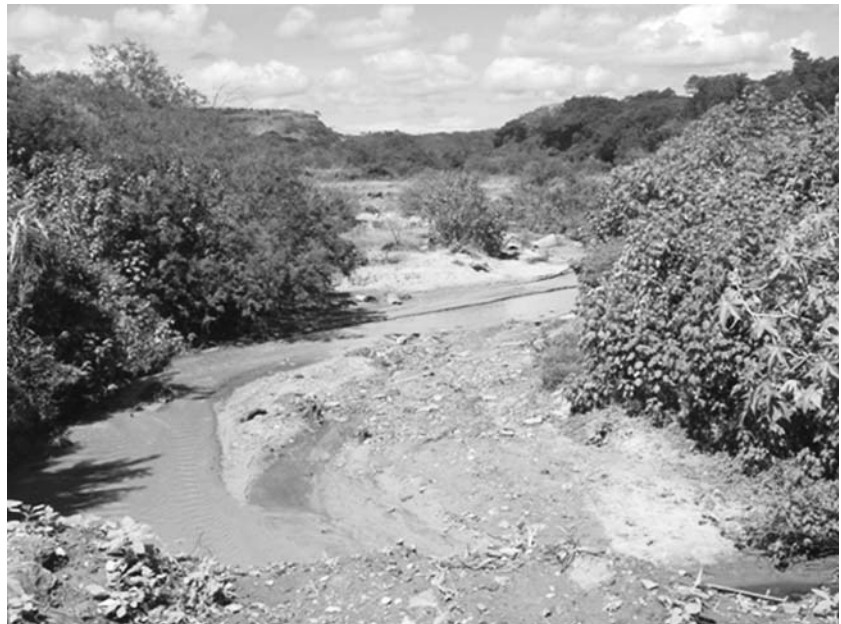
**Fig. 10** Silting area in the Agua Quente stream in the western region of the city

In the areas affected by silting, the main material found is alluvial material, whose characteristics are similar to those of Sandy I, with the presence of organic matter. At some points of the Água Quente stream (Fig. 10) in the city’s western region, silting was caused by anthropic action, i.e., deforestation of riverbanks and shifting of the path of the drainage canal.

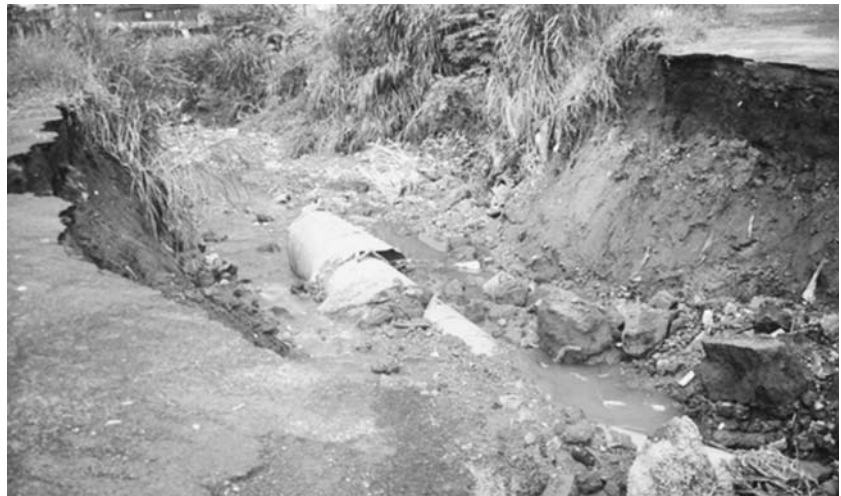
**Fig. 11** Riverbank erosion and damage to the urban infrastructure due to action of rains on the unprotected land in the edges of Tijuco Preto stream in the central region of the city

Degradation resulting from the removal of gallery forests was observed along 109 km of the city’s watercourses, and the total extension of these waterways is approximately 150 km. The main cause for this deforestation is the intense and unplanned urban occupation. The absence of gallery forests leads to increased runoff and the carrying away of soil particles, leading to erosion of the riverbanks and silting of the streams. Figure 11 shows the riverbank erosion and damage to the urban infrastructure resulting from heavy

rains on the land unprotected by vegetation on the banks of the Tijuco Preto stream in the city's central region.

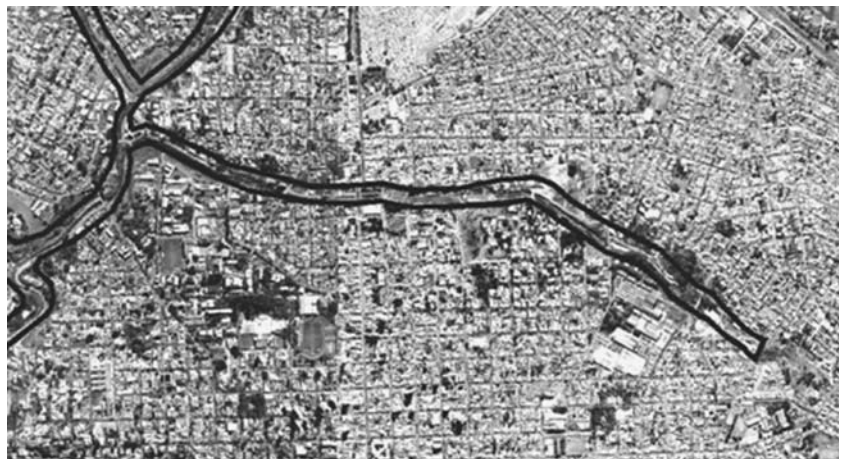
**Fig. 13** Orthophotos mosaic with overlapping of the vector of draining and the ambient degradation for deforestation of gallery forest. It was possible to measure the extension of the edge of Tijuco Preto stream, in the central region of the city, where the gallery forest was removed

The use of the orthophotographs in the environmental degradation study allowed for measurements to be made of the city's streams and of the stretches of riverbank vegetation removed. Figure 13 shows the mosaic of the orthophotographs, indicating the length of the deforested banks of the Tijuco Preto stream located in the city center. In this case, it was found that the entire length of this drainage canal (3 km) is devoid of gallery vegetation and that the urban occupation did not respect the watercourse protection limits.
