# Environmental impact on construction limestone at humid regions with an emphasis on salt weathering, Al-hambra islamic archaeological site, Granada City, Spain: case study

**Abstract** Al-hambra is an immense and valuable archaeological site in Spain built on Sabika hill with red brick and natural sandy limestone. It exhibits weathering features indicating salt weathering process. The main aim of this study is to examine weathering processes and intensity acting on Al-hambra. Rock petrography and mineralogical composition have been examined using thin sections, scanning electron microscope, X-ray diffraction and X-ray fluorescence; limits of rock's physical parameters using ultrasonic waves and mercury porosimeter; rock salt content through hydrochemical analysis. Salts attacking this structure are mainly from wet deposition of air pollutants on the long term chemical alteration of rock's carbonate content to its equivalent salts. The salts' concentration limit within the examined rock samples is considerably low but it is effective on the long run through hydration of sulphate salts and/or crystallization of chloride salts. Rock texture type and its silica as well as clay conte

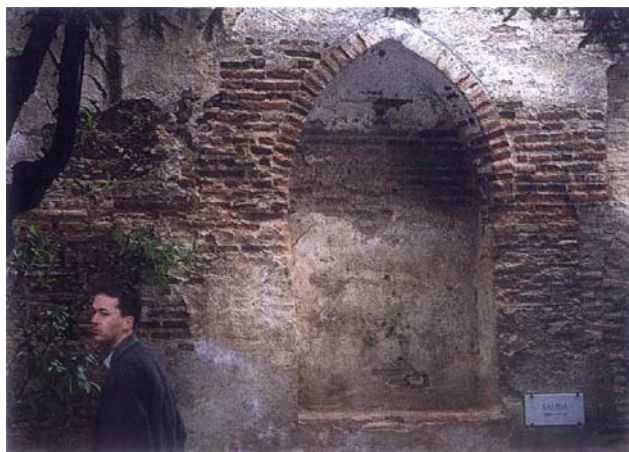
**Fig. 3** Stone surface disintegration, damp stone surface and obliteration of surface render at Salida, Al-hambra structure

Smith 1994). In Summer time, the climate is arid at the study area and hence, chloride salts are able to crystallize within rock pores as well as at the stone surface. Such salts exert high crystallization pressure within rock pores, resulting in deterioration of rock texture and formation of salt weathering phenomenon as recorded at the study area (Figs. 3, 4, 5).

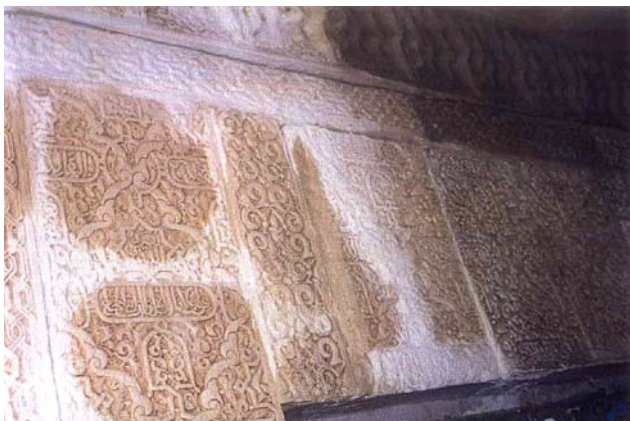
**Fig. 4** White salt efflorescence on the Islamic ingaves at Al-Cazaba Palace, Al-hambra

It has been conducted for the extracted solutions prepared [following the method of Rhoades (1982)] for eight rock samples collected from the weathered parts (Figs. 4, 5), the results are listed in Table 3. This is to clarify how much total dissolved salts are present in these weathered parts as well as type of hypothetical dissolved salts that control weathering intensity (Cooke 1994).

The noticeable sulphur content indicated by XRF and detected in the hydrochemical analysis as sulphate salts reflect the pollution level at the study area in the long term. This sulphur reacts with the calcium content of the construction limestone forming CaSO<sub>4</sub> salt. Sulphates are also expected to be derived from spray of the water running within Al-hambra where it has CaSO<sub>4</sub> and Na<sub>2</sub>SO<sub>4</sub> presenting the highest percentage of its hypothetical dissolved salts (Table 3). Generally, salt weathering impact is severely noted on the Islamic ingaves at some parts (e.g. Al-Cazaba) of this building.

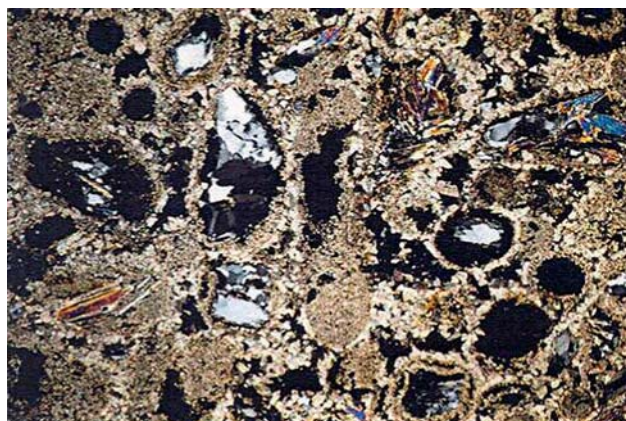
**Fig. 7** Thin section photomicrograph presenting sandy limestone with evaporates “gypsum and halite”, Al-Hambra construction rock

Thin section study has been conducted for the limestone constituting some parts of Al-hambra, indicating that this construction rock is sandy limestone with rounded carbonate allochems, mono to polycrystalline subrounded wavy extinction quartz grains. The allochems are cemented by micrite and microspars and inter and intragranular porosity can be noted (Fig. 7). Such limestone is defined as sandy limestone of wackestone texture.

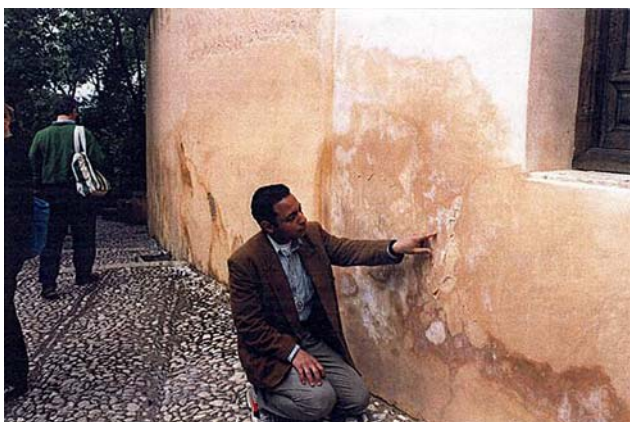
**Fig. 5** Damp stone surface, pop-outs, white salt efflorescence and render obliteration noted on wall side of Al-hambra

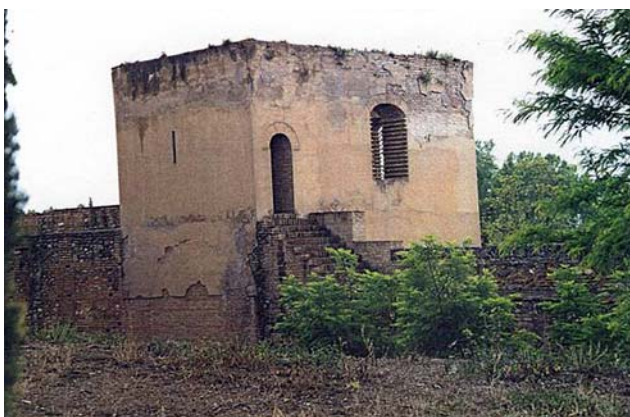
**Fig. 6** Narrow single to map cracks at some parts of Al-hambra, 35% of the surface render are obliterated, tiny plants grow up through these cracks

Structurally, Al-hambra is divided into four main parts, namely; the Generalife: “this means the garden of the architect which is consisted of beautiful gardens”; the Medina or Town: “It occupies the largest part of the walled area within the upper Al-hambra conserves, the ruins of several houses, baths and small workshops”; the Palaces: “Nasrid Palaces consist of a number of brilliantly designed and decorated function rooms and were used by the Muslim rulers for different purposes”; and Al-Cazaba or Fortress: “this military fortress was built on the oldest site of the Al-hambra, it was situated on the highest part of the hill watching over the surrounding area, the original construction had 24 towers but only a few remain” (Fig. 2). Some parts of Al-hambra have been constructed from red brick (Fig. 3) and others from natural limestone. The weathering features are noted as white salt efflorescence, pop-outs and damp stone surfaces (Figs. 4, 5), disintegration of construction stone surface and render (Figs. 3, 5); narrow single to map cracks associated with vegetation growth within these cracks can be noted (Fig. 6).

Plant growth within some cracks of this building's walls (Fig. 6) is a reflection of air humidity or rock moisture content that enables salt hydration at low temperature. Such plant growths result in increasing the width of cracks' aperture and such cracks are good micro-environment for moisture condensation; consequently, wet deposition of air pollutants takes place reacting with rock's carbonates forming aggressive salts acting on Al-hambra as noted and examined in the current study Table 5.

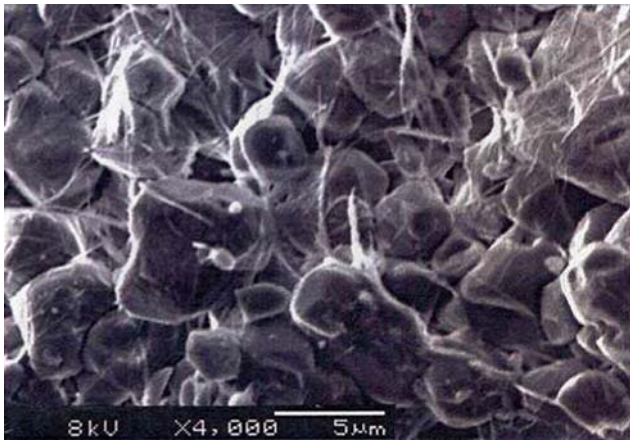
**Fig. 8** Scanning electron photomicrograph presenting rock micro-porosity, cement type and illite within texture of construction rock of Al-Hambra

Scanning electron microscopic study has been conducted on this construction rock to clarify in detail about the matrix. It indicated that the matrix is not only microspar but also illite as clay mineral (Fig. 8).

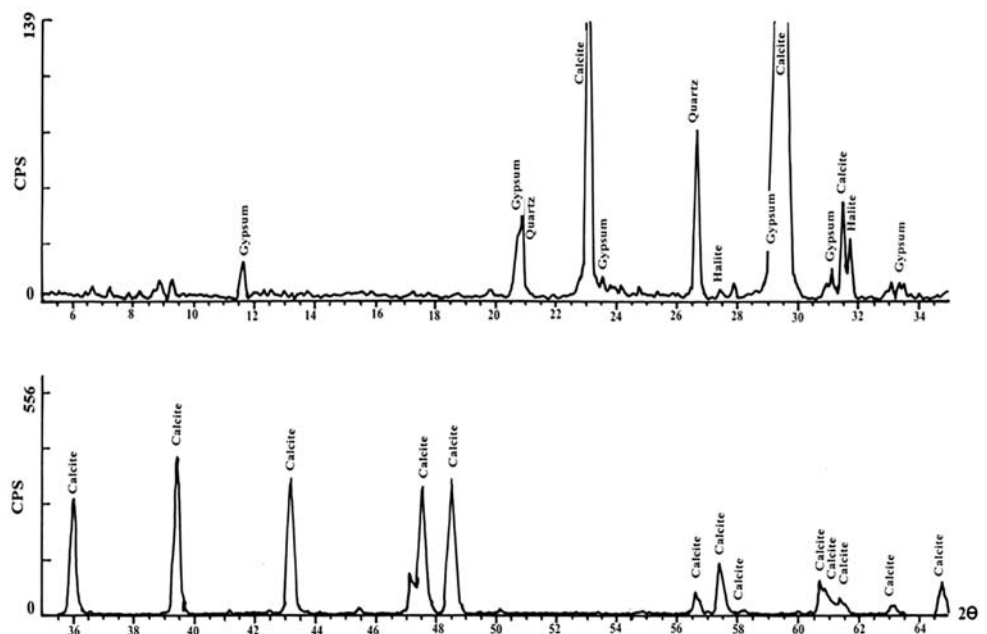
**Fig. 9** X-ray diffraction chart presenting mineralogical composition of rock

X-ray diffraction has been conducted for the sandy limestone of Al-hambra, indicating its mineralogical composition to be mainly calcite, then gypsum, quartz and halite (Fig. 9).
