Assessment of rockfall hazard around Afyon Castle, Turkey

Tamer Topal · Muge Akin · Utku Ahmet Ozden

Abstract The Afyon Castle is a tourist destination and a historical site in the City of Afyon in Turkey. The Castle is located on a steep hill, with a height of 226 m. In close proximity to the Castle there are settlements. The hill consists of trachitic andesite. The rock contains columnar joints and flow layering. Owing to these discontinuities, blocks of varying sizes had fallen down. The settlement areas near the Castle are now in danger because of the rockfall risk. In this study, rockfall analysis was carried out along nine profiles of the hill. Fall-out distance, bounce height, kinetic energy and velocity of the rocks along each profile were investigated. The results of the analyses were evaluated, and the areas delineated as susceptible to rockfall risk are highlighted. Remedial measures including rock bolts and protective fences were suggested on the basis of the field observations and the rockfall risk evaluation.

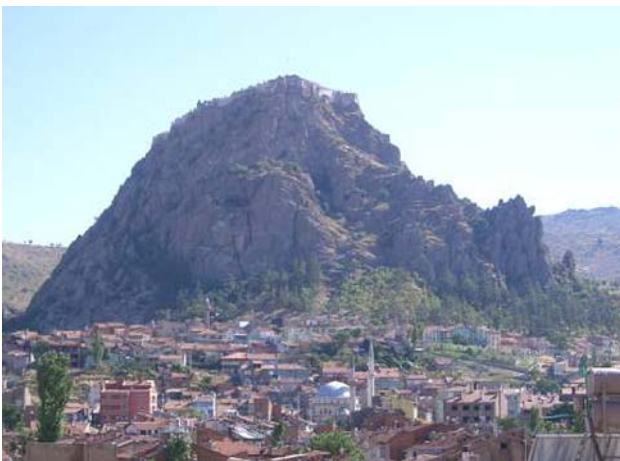
Fig. 2 General view of the Afyon Castle and settlement area

snow. The Castle is located on a steep hill at a height of 226 m (Fig. 2). In close proximity to the Castle, there are settlements and historical buildings that should be protected. However, rock blocks of varying sizes had fallen down and the settlement areas around the Castle have been in danger of rockfall. In this study, the rockfall hazard around the Afyon Castle was investigated. Two-dimensional rockfall analyses were carried out along nine profiles. Various rockfall-related

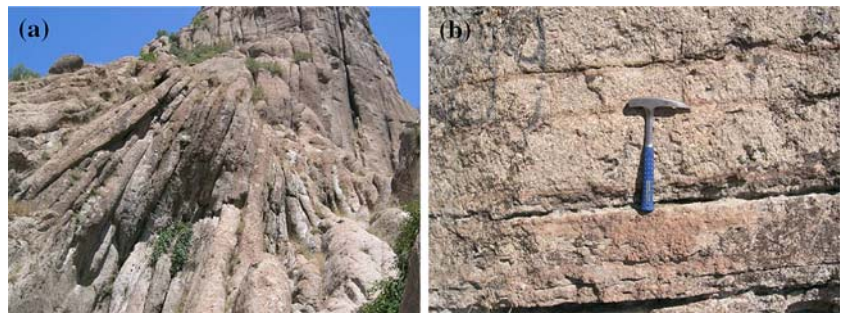
Fig. 4 Photograph of **a** the cooling joints and **b** flow layering in the trachitic andesite

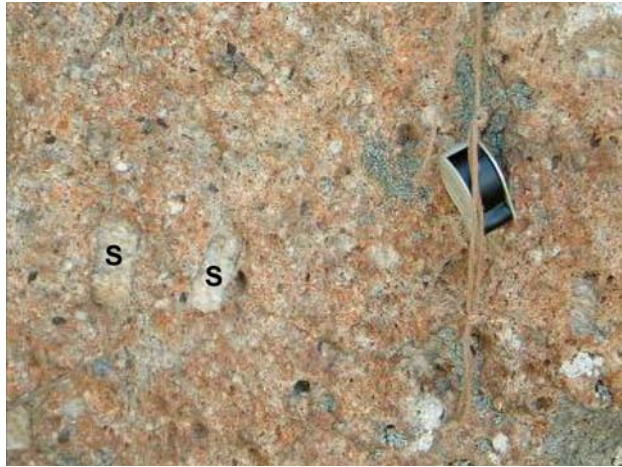
Fig. 5 Sanidine (S) phenocrystals in the trachitic andesite

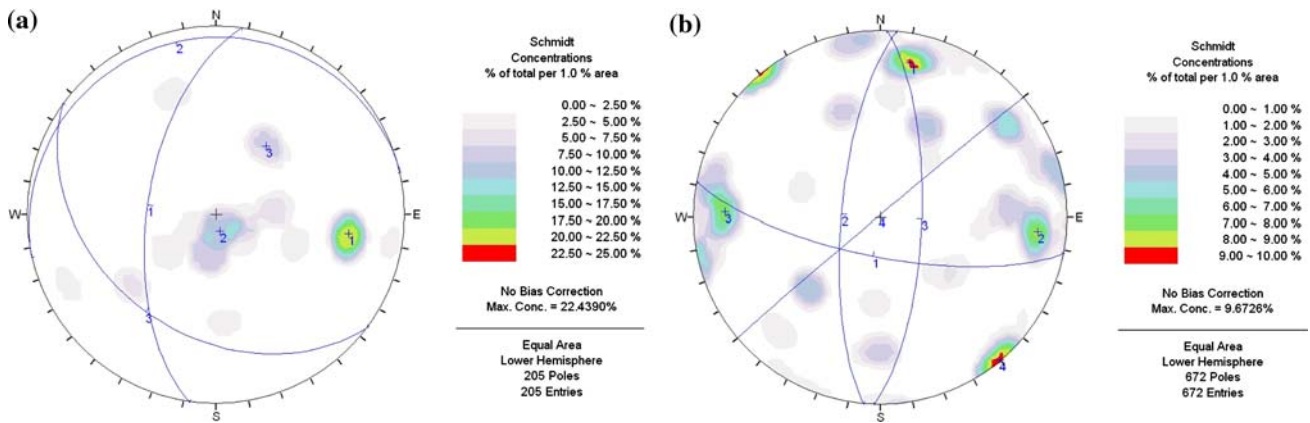
Fig. 6 Contour diagrams and dominant discontinuity sets of the andesite: **a** flow layering, **b** cooling joint

The scanline surveys carried out in the field reveal that the andesite has four dominant cooling joint sets (73/191, 73/245, 72/092, 89/320) and three dominant

flow layering sets (60/278, 07/347, 37/216) (Fig. 6). The discontinuities have very high persistence (>20 m), mainly tight aperture (very wide near the surface). Very wide apertures observed near the surface contain sandy and clayey infilling, but most are free of any kind of infilling. The average spacings of the cooling joints and the flow layering are 0.57 and 0.65 m, respectively. The variations of the discontinuity spacing (Fig. 7a, b) display negative exponential relationship which is in good agreement with Priest (1993). The discontinuity surfaces are generally rough undulating. The andesite is slightly to moderately weathered. No groundwater seepage was noted through the discontinuities in the study area.

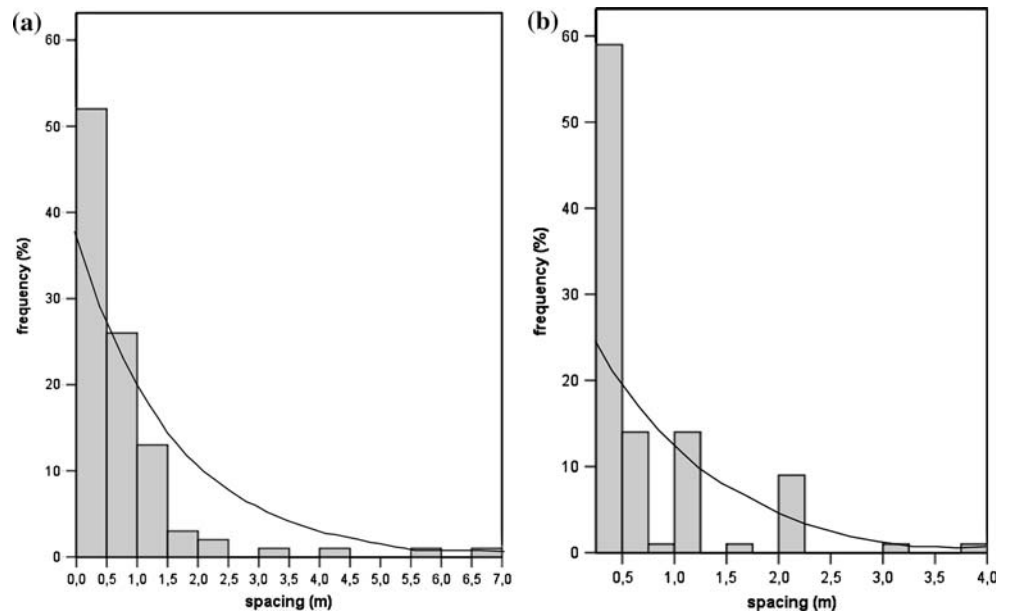
Fig. 7 The variations of the discontinuity spacing in the andesite: **a** flow layering, **b** cooling joint

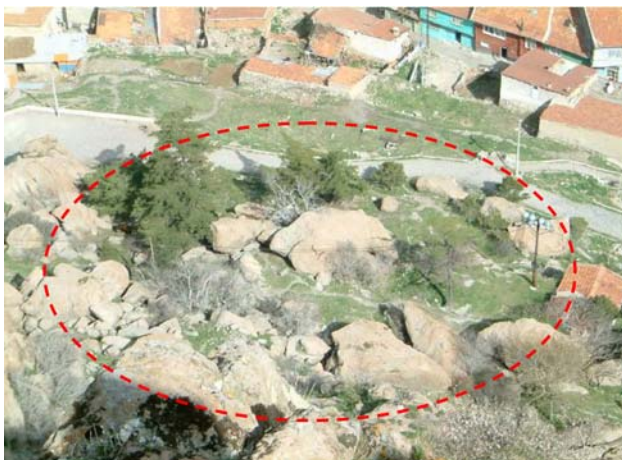
Fig. 8 Photographs showing various sizes of blocks fallen down

of centimetres to a few metres. As a result, both small and large blocks are formed. Jointing, freeze–thaw, water effect, earthquake tremors, and tree roots are expected to be the main causes of the rockfalls in the study area. The largest fallen block observed is approximately 8 tons (Fig. 8).

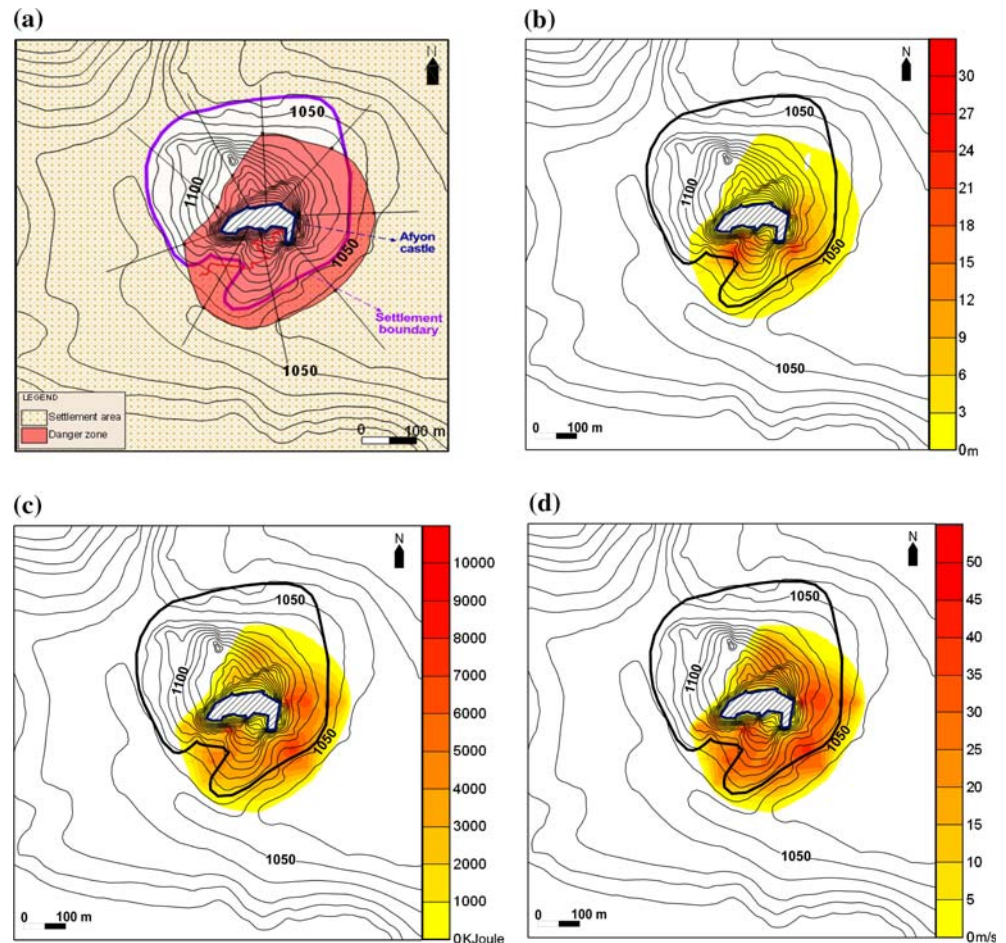
Fig. 12 Maps showing **a** fall-out distance, and variations of **b** bounce height, **c** kinetic energy, and **d** velocity during and after rockfalls for 10,000 kg rocks

On the basis of the analysis, the normal and tangential coefficients of restitution of the rocks are found as 0.47 and 0.79, respectively. These and other selected parameters (see Table 2) were used for the rockfall analysis. A typical analysis showing the variation of fall-out distance and bounce height of a block 10,000 kg in weight is shown in Fig. 9a and b. The aerial extents of the fall-out distance, bounce height, kinetic energy and velocity of the rocks along nine profiles by considering blocks of different weights (100–10,000 kg) representing the field conditions are shown in Figs. 10, 11 and 12.

On the basis of the rockfall analyses, the maximum fall-out distance ranges between 40 and 255 m from the source area located just beneath the Castle wall. Bounce height reaches a maximum value of 28 m along the trajectory. On the other hand, maximum kinetic energy is in the order of 9,012 kJ. The blocks attain a velocity of 42 m/s along the trajectory. Although very high kinetic energies, bounce heights and velocities of the blocks are obtained, they decrease with distance along the profile.

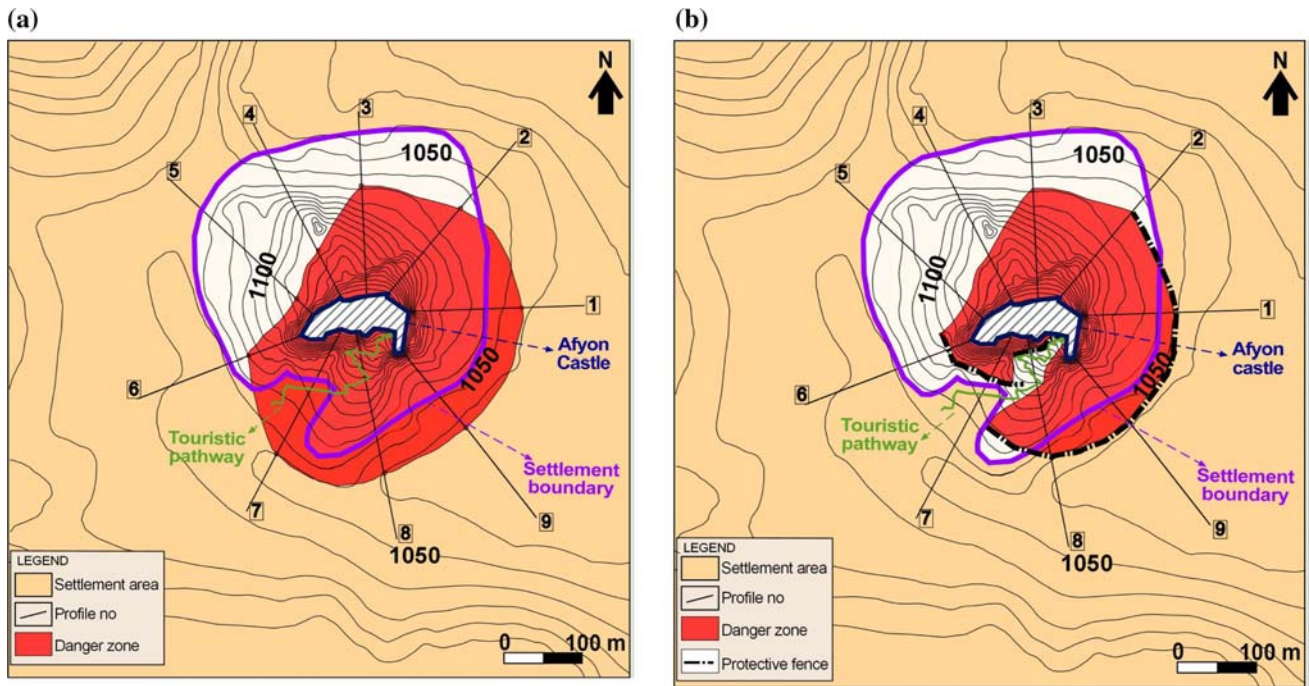
Fig. 13 Map showing the extent of rockfall danger zone around the Afyon Castle **a** before and **b** after the installation of the protective fence as a remedial measure

The rockfall analyses performed for the southern part of the Afyon Castle reveal that there exists a rockfall danger zone. The extent of the zone without any remedial measures is shown in Fig. 13a. This zone partly involves the settlement areas. The local municipality authorities indicate that there are also several historical buildings located at the southern part of this zone that must be protected. Total evacuation of the danger zone is not preferred by the authorities. Therefore, remedial measures against rockfall hazard are considered. Retaining wall and wiremesh as remedial measures are not preferred either because they adversely disturb the appearance of the historical Castle. Ditch construction is not effective for this site because of the high bounces of the blocks.

The suggested locations of the protective fences and the new danger zone after the installation of fences are given in Fig. 13b. The locations are selected such that (a) the fences are between the Afyon Castle and the settlement area if possible, (b) the fences are located where minimum kinetic energy and bounce height are achieved, and (c) the existing pathway for tourists is protected (Fig. 13b). For this reason, protective fences having a maximum height of 6 m and able to resist 3,000 kJ, which is the upper bound of the maximum capacity of the available fences, are expected to stop any potential rockfall in the future. However, the southeastern and eastern parts (along profiles 1, 8 and 9) of the Castle where the danger zone involves the settlement area will be adversely affected from the

rockfall hazard. Therefore, this portion of the area where the protective fence cannot stop the movement due to its limited energy absorbing capacity will be still in danger of rockfall and should be evacuated.
