The salt decay of medieval bricks at a vault in Brarup Church, Denmark

Poul Klenz Larsen

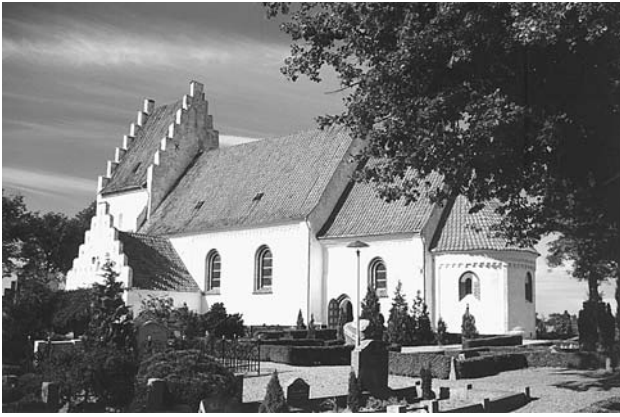
Fig. 1 View of Brarup Church from the southeast. The nave, chancel and apses are build of red brick masonry around 1300. The church is situated at the island Falster close to the Baltic Sea

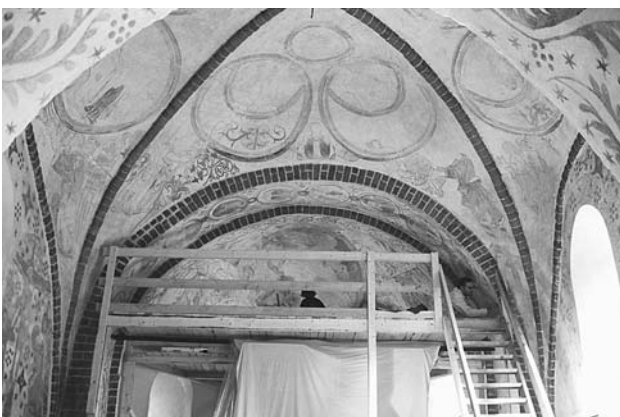
Fig. 2 View of the inside of the chancel looking towards the apse. The vault is a 250 mm thick masonry structure, contemporary with the outer walls

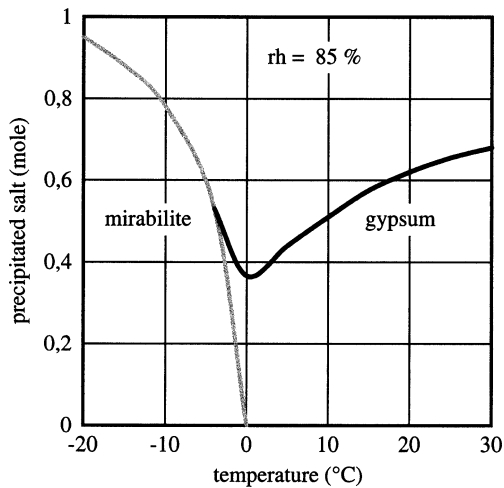
Fig. 4 The precipitation of gypsum from a mixture of 1 mol of CaSO_4 to 20 mol of NaCl in the interval -20 to 30°C at a fixed relative humidity at 85% RH. Calculated by the computer program RUNSALT

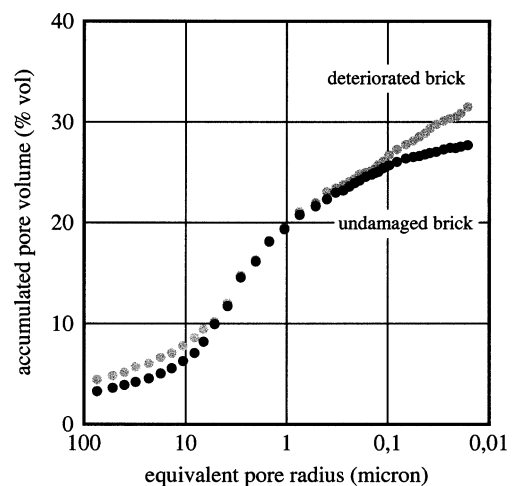
undamaged and one decayed brick. Prior to the drilling, the brick powder was removed from the decayed brick, so only solid brick were analysed. From the deepest end of the cores, 10 mm were used for thin sections and 10 mm for pore size measurements. The pore size distribution for the decayed and the undamaged bricks was measured by MIP (Mercury Intrusion Porosimetry (Fig. 8). For each sample two measurements were performed. The diagram represents the average values. The undamaged bricks and the damaged bricks both had a majority of pores in the range of 1–10 μm. In the damaged bricks there were also a considerable fraction of pores in the range 0.01–0.1 μm.

Fig. 8 The pore size distribution of a damaged and an undamaged brick, measured by Mercury Intrusion Porosimetry (MIP). The damaged bricks have a larger fraction of pores in the range 0.1–0.01 μm than the undamaged bricks

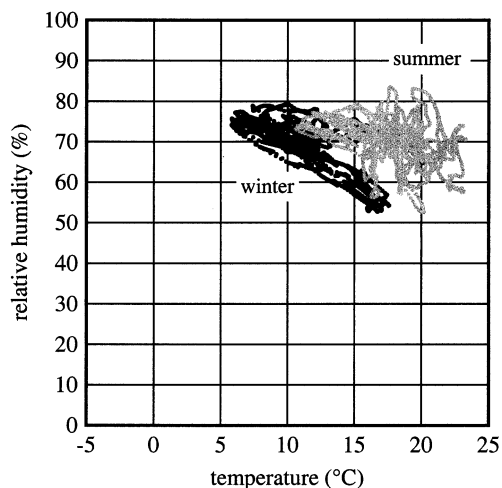
Fig. 13 Climate measurements in the nave over 1 year. Each point represents the running average of 24 h of temperature and relative humidity. The grey points are in summer and the blacks points are the winter season. The curved shape of the winter cluster illustrates the influence of the intermittent heating
