Ozgu Kasmer
Resat Ulusay
Candan Gokceoglu

Spoil pile instabilities with reference to a strip coal mine in Turkey: mechanisms and assessment of deformations

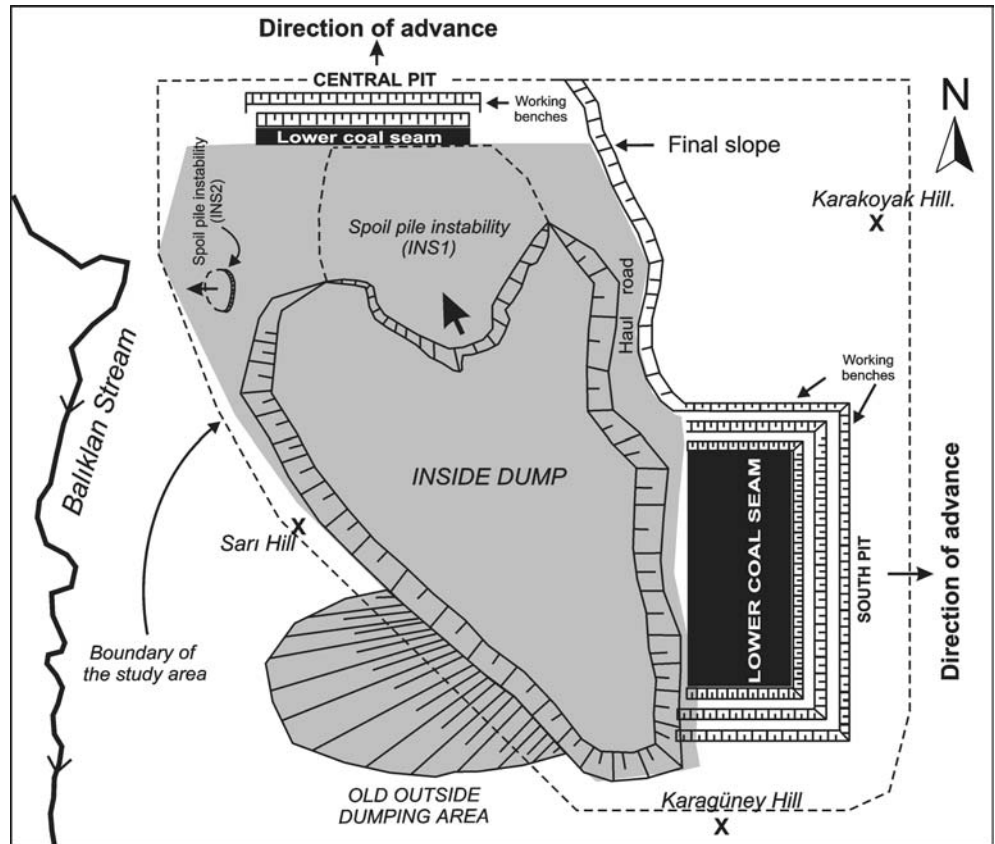
Fig. 2 Simplified layout plan of the open pits and dumping areas, and locations of the spoil pile instabilities

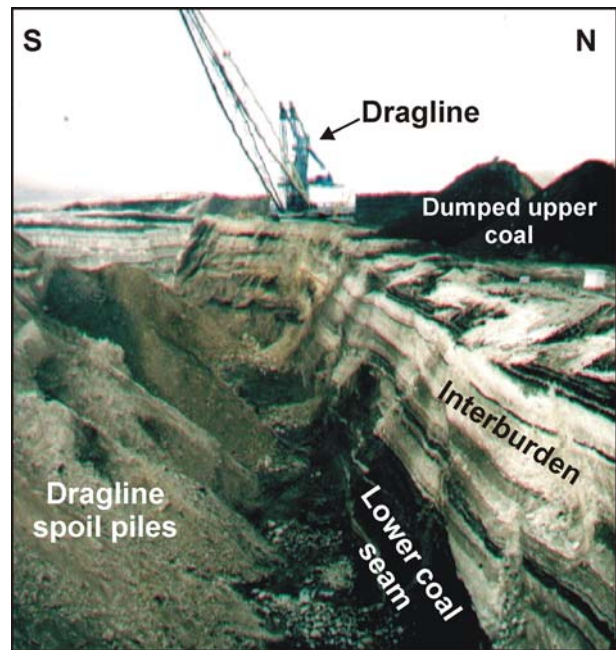
Fig. 3 Panorama illustrating the stripping operation by the dragline in the Central Pit

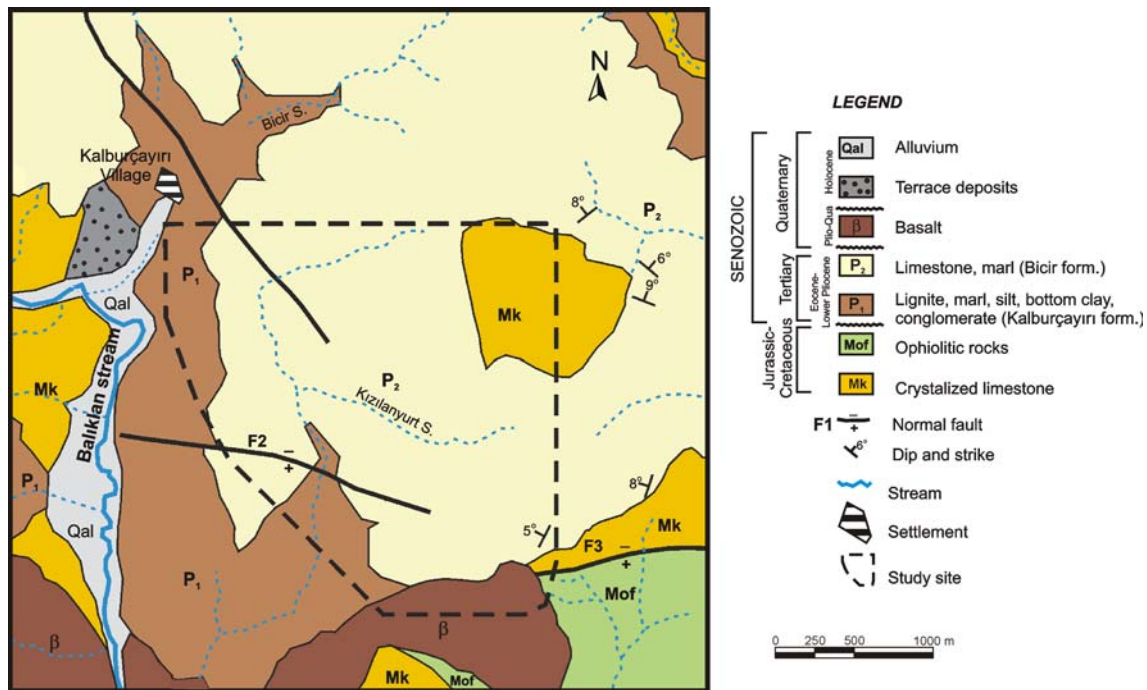
from 4° to 6°. The plunge of the syncline axis in the Tertiary units is between 3° and 4° toward the NNW. Only very small faults are visible on the pit walls. However, borehole data obtained from MTA (1976) suggest the presence of three main normal faults shown in Fig. 4.

Fig. 4 Geological map of the study site (rearranged from MTA, 1976)

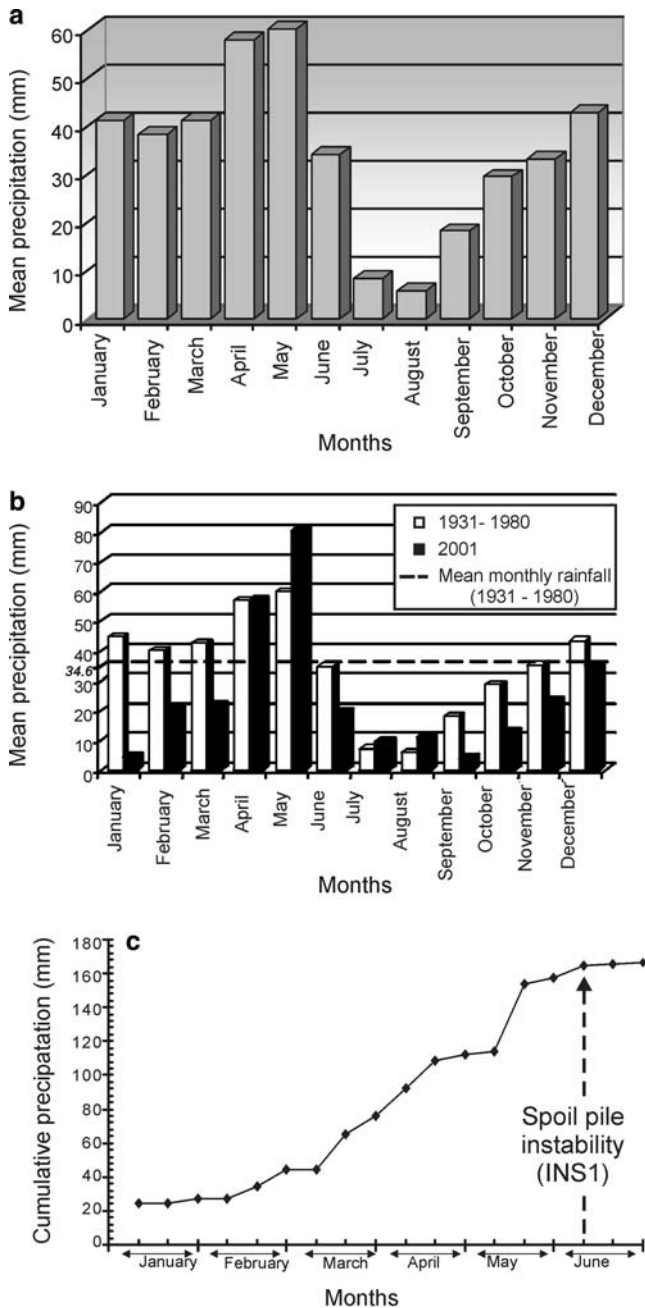
The comparison between the mean monthly precipitation from 1931 to 1980 and in 2001 (Fig. 5b) suggests that the precipitation in May 2001, before the spoil piles failed, is considerably higher than the mean precipitation for May. In addition, the cumulative precipitation to May 2001 was considerably higher than the average (Fig. 5c).

Fig. 5 **a** Histogram showing the mean monthly precipitation between 1931–1980 and 1992–2002, **b** comparison of mean monthly precipitation between 1931 and 1980 and the year of 2001, **c** cumulative precipitation for the first 6 months of 2001 and date of spoil instability INS1

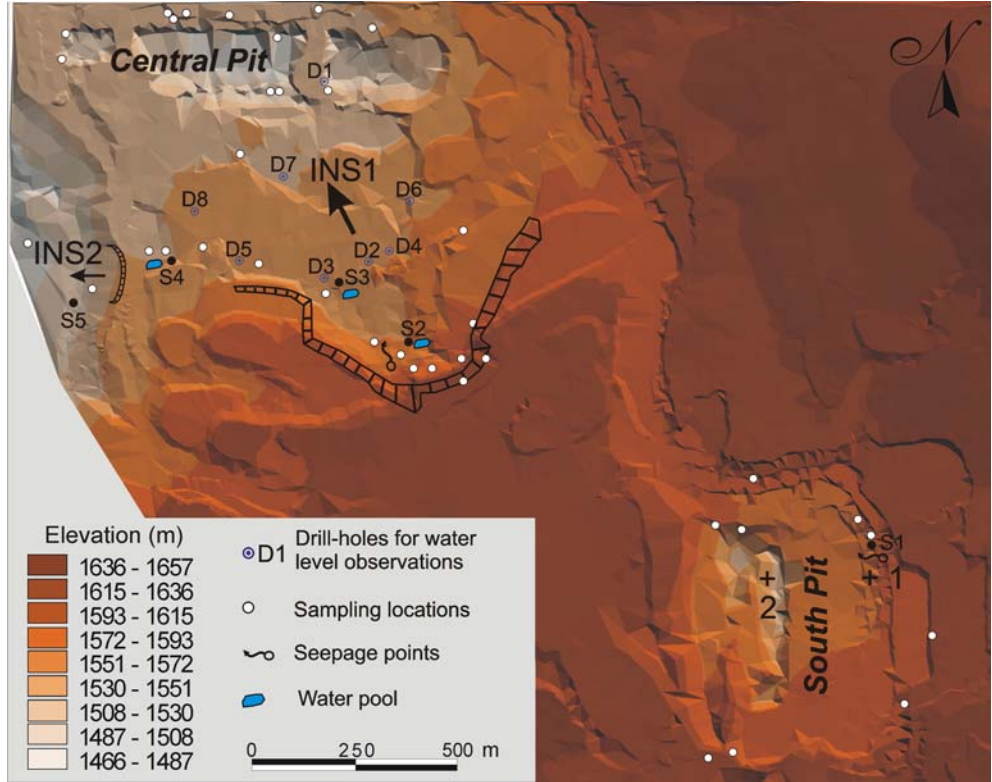
or surface runoff (location 2 in Fig. 9). In addition to a few seepage locations, there also exist some water pools from the east to the west in the area of INS1 at the Central Pit (see Fig. 9). These observations suggested two scenarios. Firstly, as a result of the depositional structure of the spoil, some quantities of water may seep

down through discrete zones in the spoil to the base. Secondly, the water accumulated at the base of the South Pit (location 2 in Fig. 9) may flow from the floor below the spoil dumps between the two pits towards the spoil piles at the Central Pit.

Fig. 9 Locations of the hydro-geological investigations involving water-well drilling, water sampling and observations

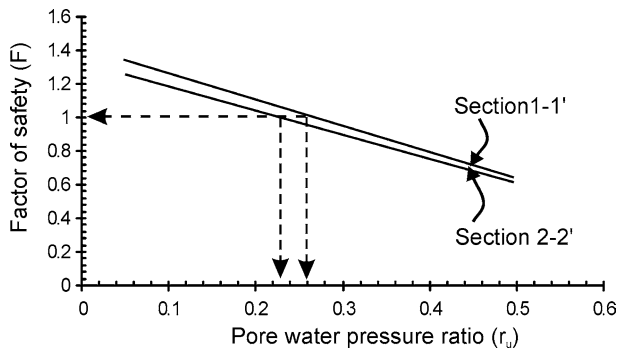
Fig. 13 Variation of factor of safety with pore water pressure ratio for INS1.

Back-analyses were carried out to assess the sensitivity of the spoil piles to variations in pore water pressure and to estimate the r_u values satisfying the limit equilibrium condition for the two cross-sections from the failure shown in Fig. 6. The results shown in Fig. 13 suggest that pore water pressure ratios satisfying the limit equilibrium condition are 0.26 and 0.23 for cross-sections 1-1' and 2-2', respectively. These r_u values are equivalent to a material that is approximately 45–50% submerged. It should also be remembered that, as discussed in hydrogeology section, heavy rainfall occurred about 1 month before the failure (see Fig. 5). Infiltration of the rainfall into the spoil materials would likely have led to an increase in pore water pressure just prior to the failure. In addition, the floor geometry promoted groundwater flow towards the mining face, reducing the shear strength of the interface between the floor and the spoil piles. Both these effects would contribute to instability.
