## Assessment of environmental and engineering geological problems for the possible re-use of an abandoned rock-hewn settlement in Urgüp (Cappadocia), Turkey

**Keywords** Cappadocia · Environmental conditions · Kayakapi (Urgüp) · Rock fall · Stability of underground opening · Troglodyte · Tuff

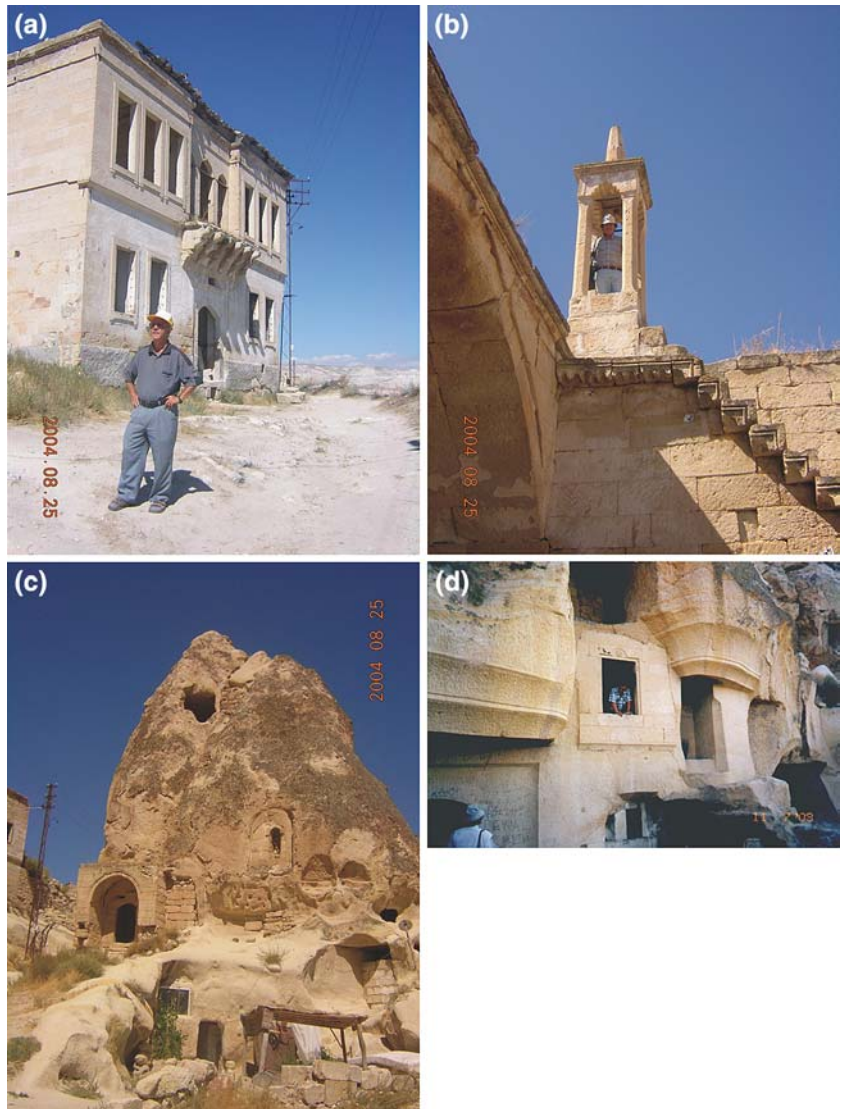
**Fig. 5** **a** A masonry structure (Yusuf Aga's Palace), **b** a mosque from the Seljukian period, **c** a rock-hewn church, and **d** a group of troglodytes in the Kayakapi Neighborhood

The presence of some very shallow-seated openings, which have very thin overburden or are located below the road or any structure, indicates bearing capacity problems. Such openings should be filled with blocks and application of injection to fill voids between the blocks to prevent unexpected collapses. Particularly, the troglodytes located below the rock-hewn church (see Fig. 5c) should be filled for structural stability of the church.

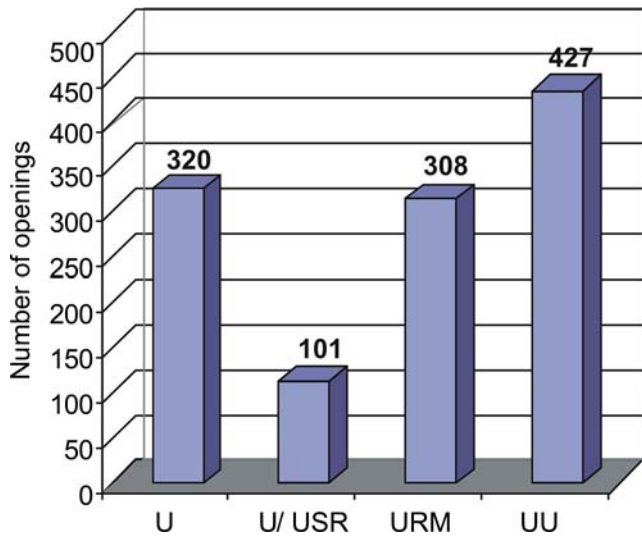
**Fig. 17** Histogram of the categorized troglodytes at Kayakapi based on the troglodyte inventory (*U* usable, *U/USR* usable/usable after some remediation, *URM* usable after remedial measures, *UU* unusable)

Based on the above-mentioned criteria and categories, a troglodyte inventory for the Kayakapi Neighborhood was prepared. The statistical evaluation of this inventory is depicted in Fig. 17. The number of troglodytes, which can be directly used, is 320, while there are 427 abandoned openings which should not be re-used. If the necessary remedial measures are done for the classes *U/USR* and *URM* in Fig. 17, the number of usable openings can increase up to 729.

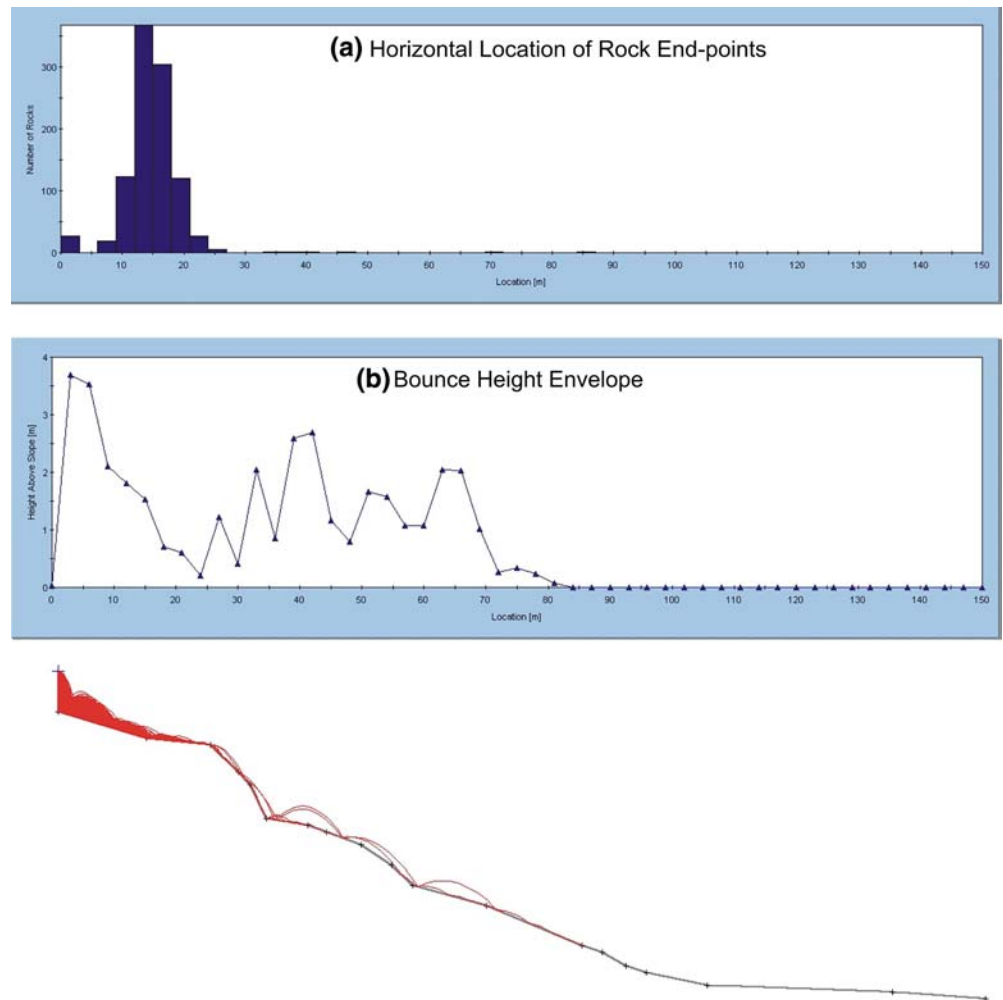
**Fig. 21** The variation of **a** fall-out and **b** bouncing height of a rock block 5,000 kg in mass
